THE 20th JULY 2017 (22:31 UTC) BODRUM/KOS EARTHQUAKE AND TSUNAMI; POST TSUNAMI FIELD SURVEY REPORT

August 17, 2017 (new version)

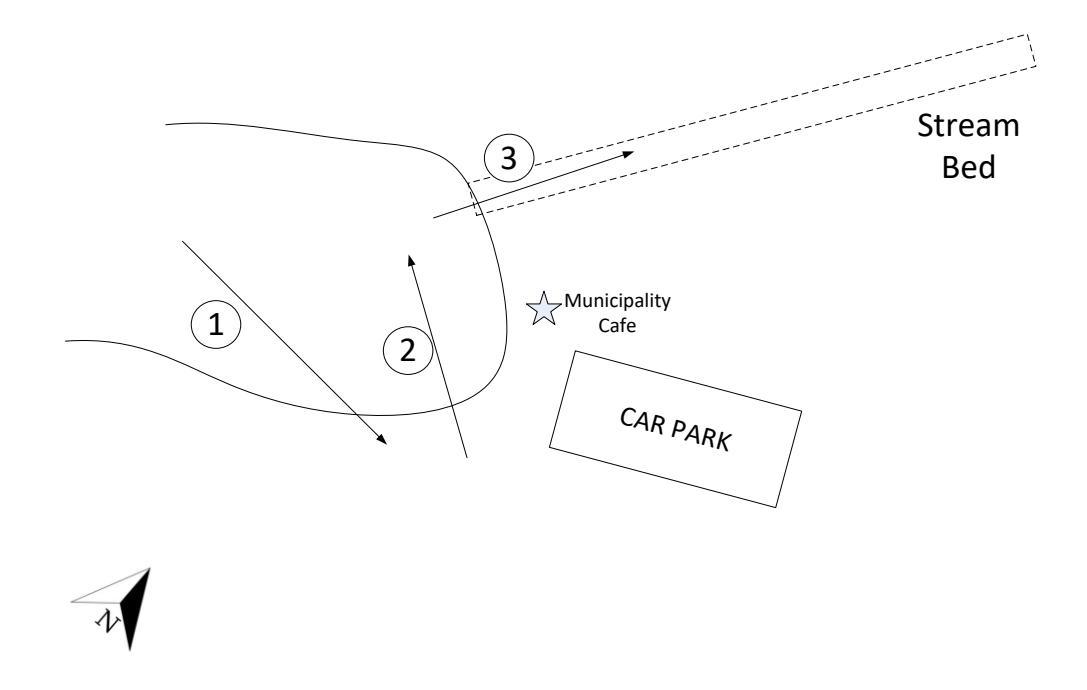
Figure 4.1: The motion of tsunami at eastern end of Gumbet Bay (Municipality café is at 27.408503E 37.029732N).

It is stated by the workers that approximately 20m of inundation is observed near the municipality café. The flow depth in front of the municipality café is measured as 0.56m in the second survey. Waves dragged the parked cars near the shoreline on the concrete bed of dry stream. Totally 12 cars have been dragged and all were collected in the same location (37.031137N 27.406882E) away from the shore at the stream and concrete planters in front of these car parking area. Eyewitnesses from the sea front restaurant staff reported successive waves (sea withdrawal and advancing) until the sun rise (about three hours after the earthquake). In the next morning after the earthquake, water level was decreased about 2m in vertical (Figure 4.2). People have found dead fish mostly near and around the stream bed, and all along the coastline of the bay. Besides, they observed remarkable increase in the number of rare insects in last couple of days on the ground.

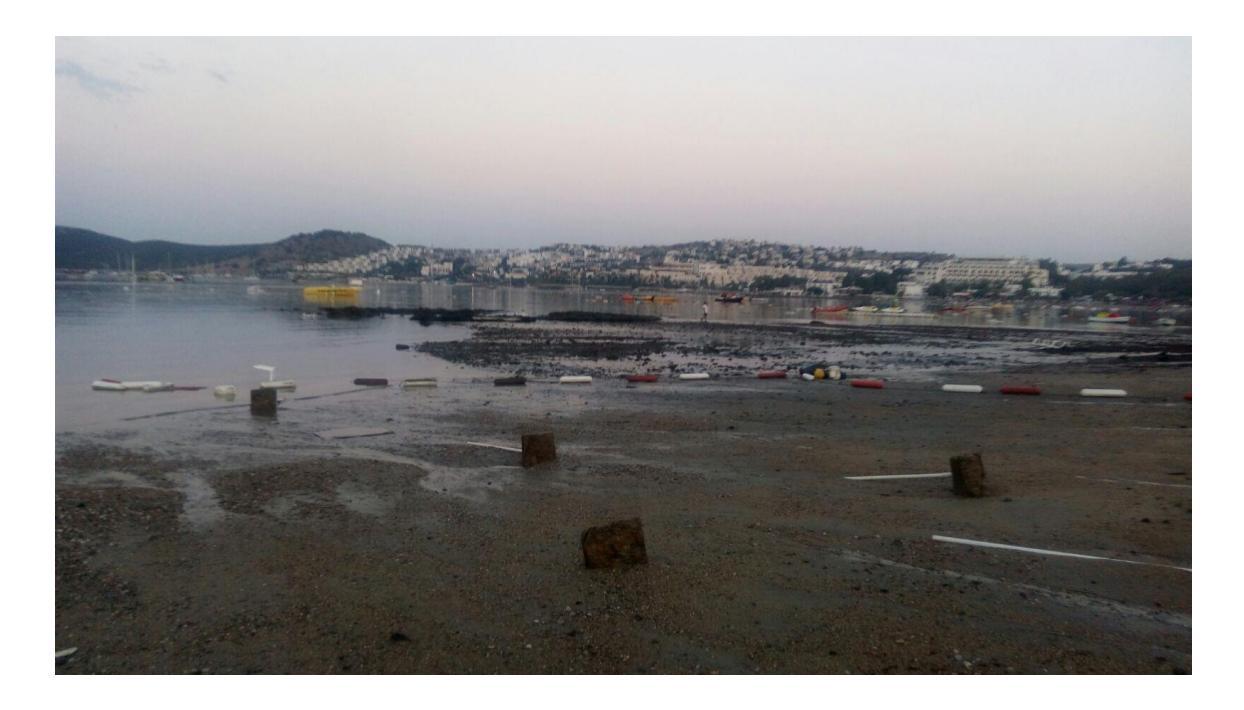
Figure 4.2: View of sea withdrawal in Gumbet Bay about three hours after the earthquake

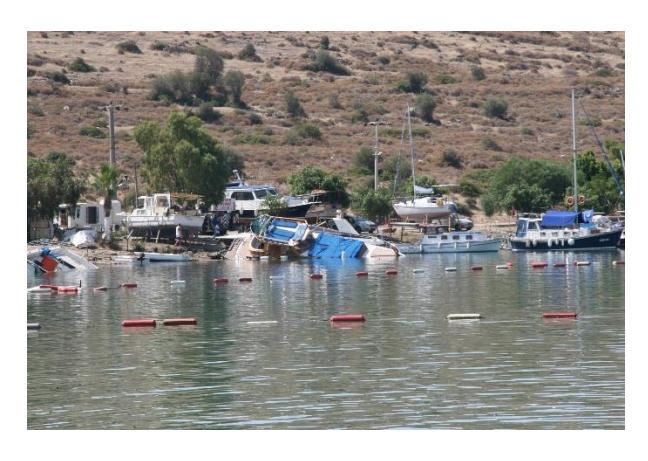
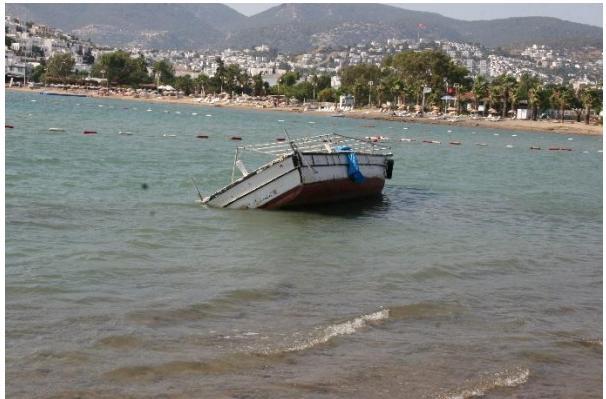
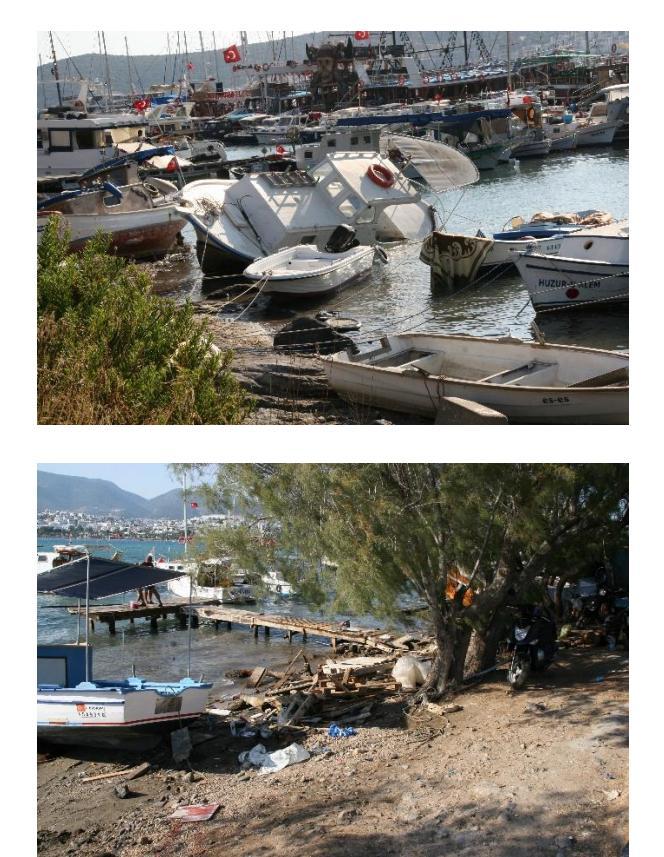
At the most eastern part of Gumbet bay (27.407621E, 37.037478N), the small boats berthed at shallow region. Tsunami dragged all boats together and moved them away from the shore to the location (27.405029E, 37.0281.33N) in the bay. More than 30 boats were damaged and more than 10 boats sunk in this location. The boat captains reported that there was very strong swirling water motion at three locations in the bay. Approximate locations are i) 27.405029E, 37.0281.33N, ii) 27.400399E, 37.029001N, iii) 27.403934E, 37.030043N. In the second survey, the run-up height is measured as 1.72m in this berthing region.

Figure 4.6: View of damaged boats and coastline of Gumbet Bay

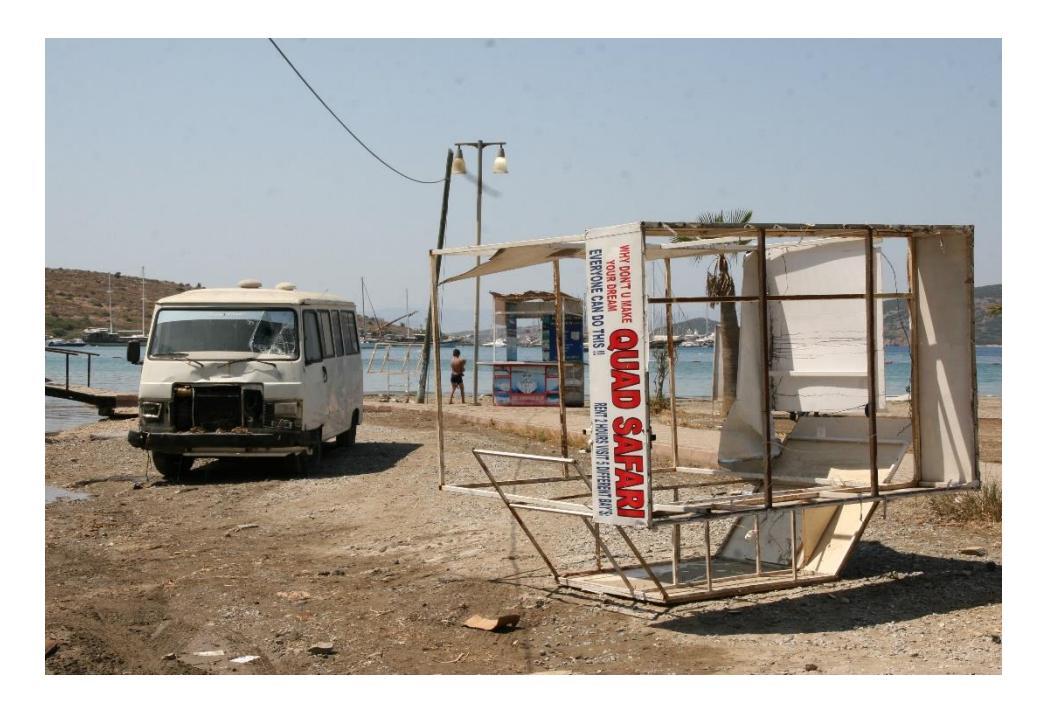
Figure 4.7: Damaged minibus and advertisement board

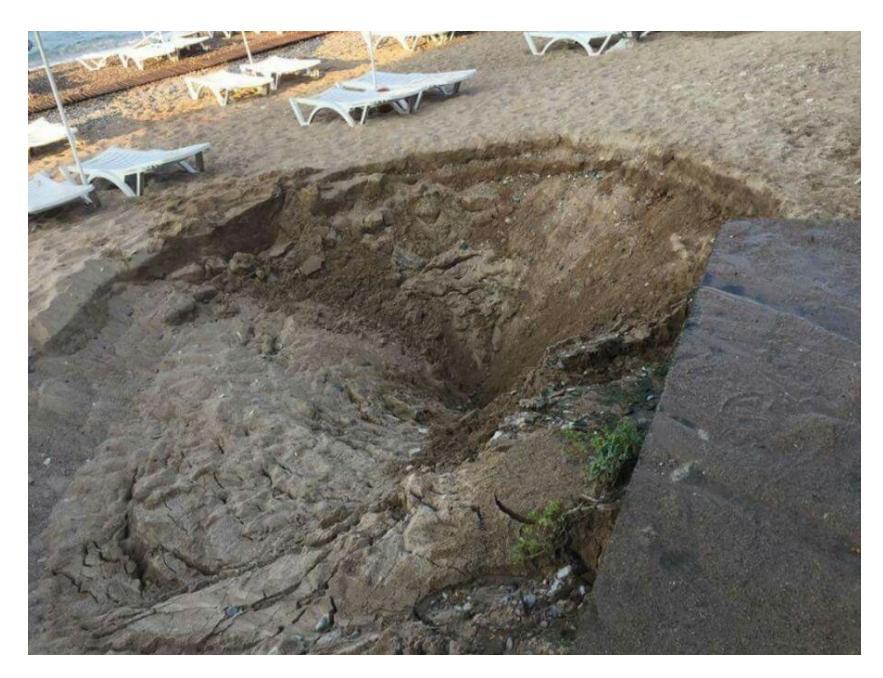
Figure 4.8: Big hole appeared at Yaliciftlik Bay after the earthquake (27.527908E 36.992786N)

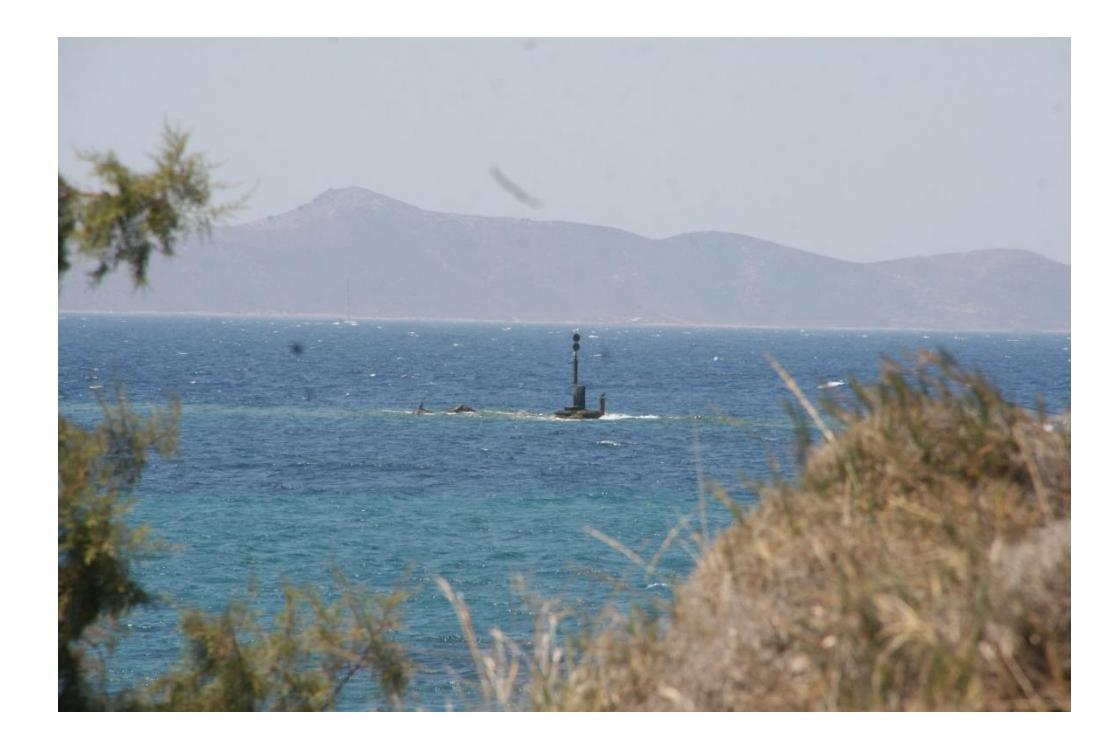
Figure 4.9: Boundary of the tsunami observation at the western end of the Southern Coastline of Bodrum Peninsula according to eyewitnesses (27.264562E 36.964772N)

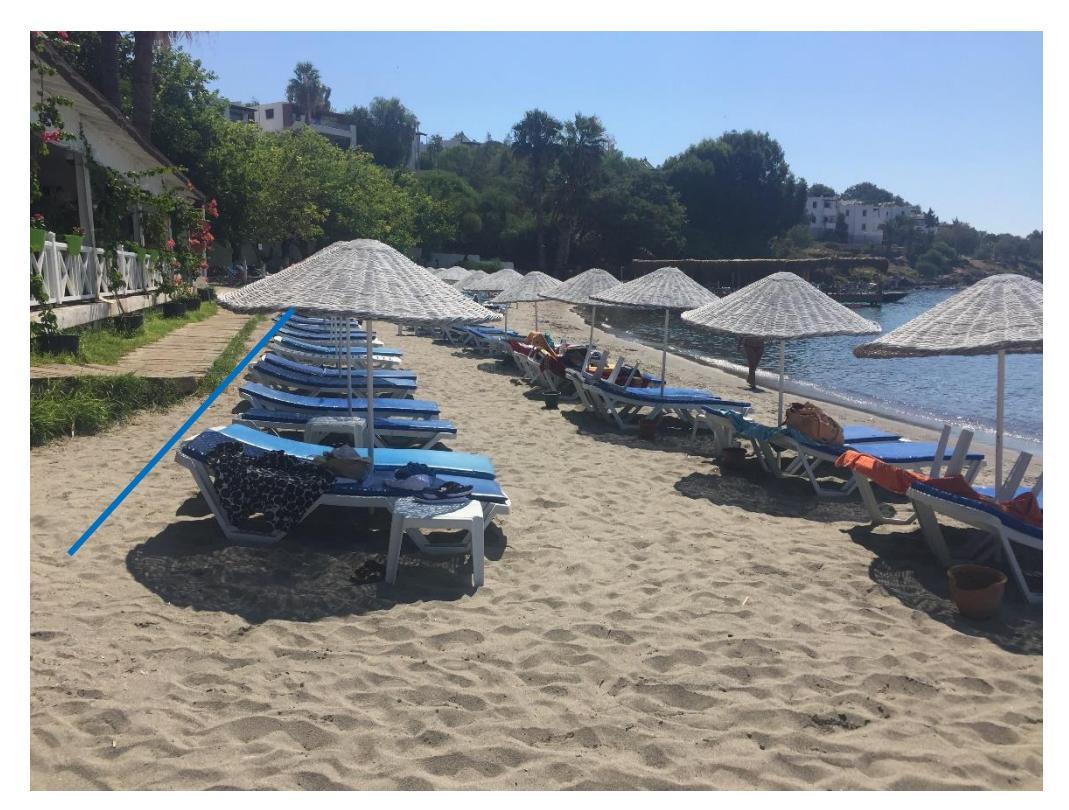
Figure 4.10: View of inundation line at Meteor Beach (27.278796E 36.966191N)

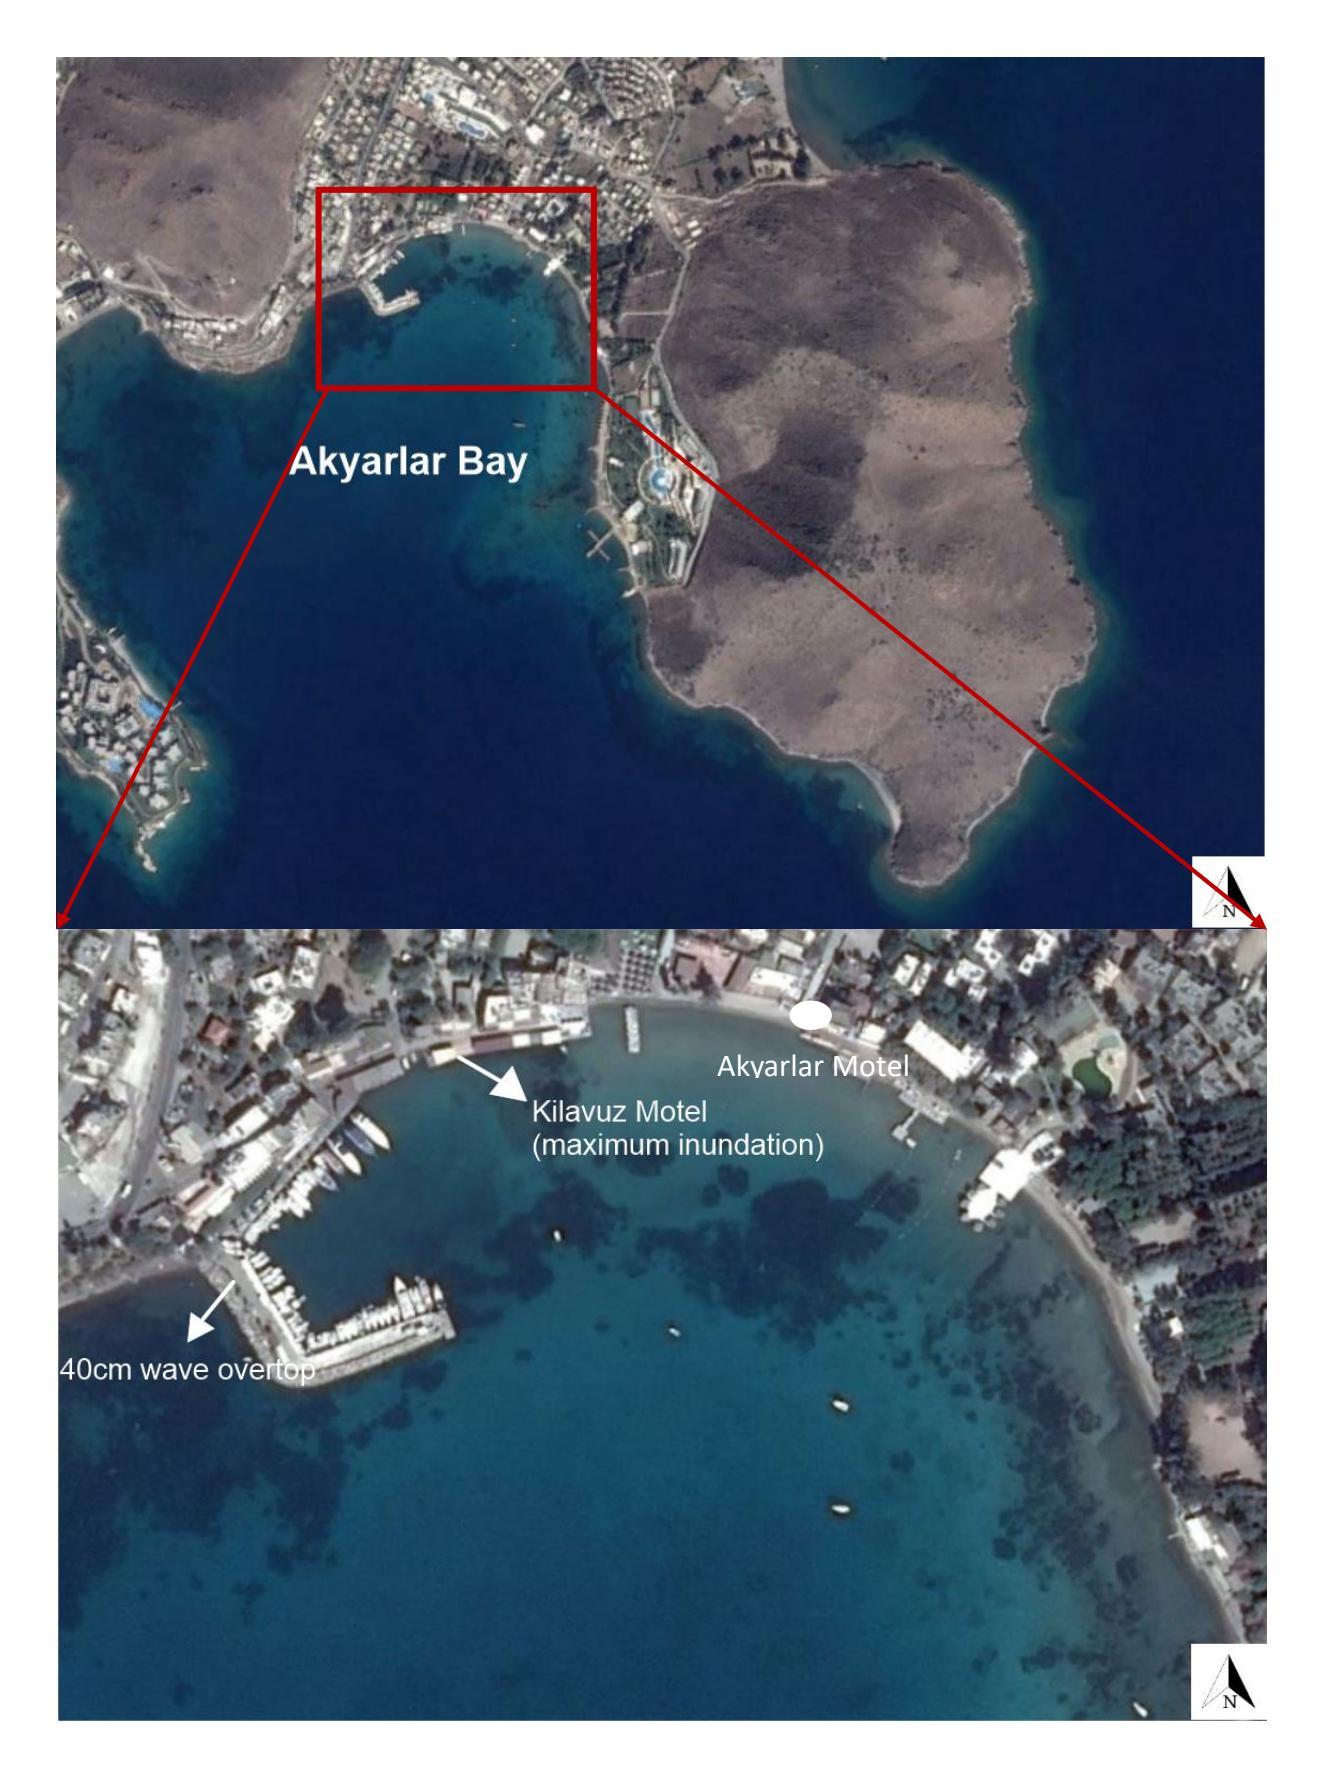
Approximately 10 meters of inundation distance is observed along the coast of Akyarlar Bay (3). One of the summerhouse residents observed that the small hole at 10-15m distance from the coast was all washed up by the waves. He stated that the flow depth was about 50cm. The port in this bay is at a safe location by the natural conditions, therefore no damage observed by the waves in the port. According to the fisherman observations in the port, the sea level first decreased and then rising was observed. Also, strong currents were observed at the nose of the breakwater, one of the fishermen said *"it was flowing like stream water at the entrance of the port"*. The dock height was measured as 80cm. The water level rise at the harbor was 120 cm according to the eyewitnesses. (Figure 4.11). Waves affected the part up to Akyarlar Motel (27.294602E, 36.967830N) if one considers a perpendicular line to the coastline from the head of the breakwater. The water level increased 40cm in front of the vertical wall of this motel. The coordinate measurements and related observations along Akyarlar Bay is given in Table A.4 in Appendix A.

Figure 4.11: Schematic view of wave motion in Akyarlar Bay (27.290930E 36.967359N)

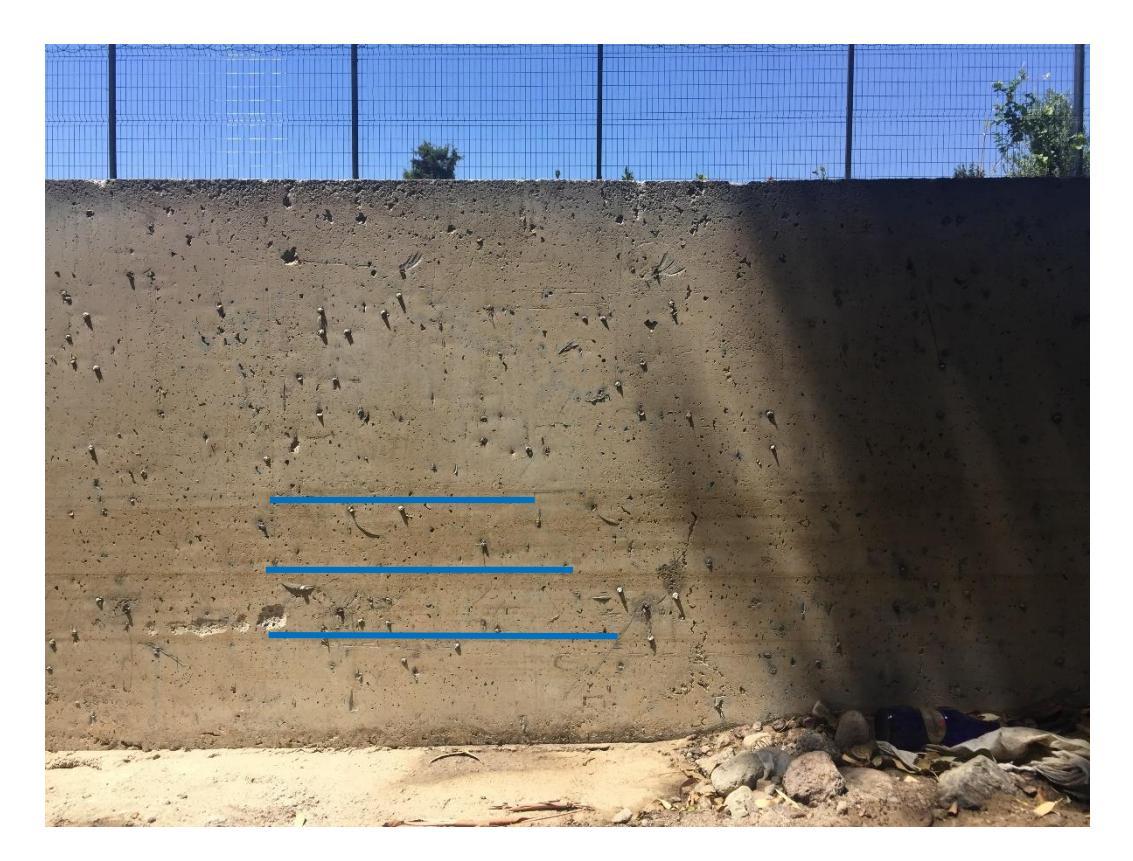
Figure 4.12: Wave traces in the stream bed, Karaincir Bay (27.300718E 36.973574N)

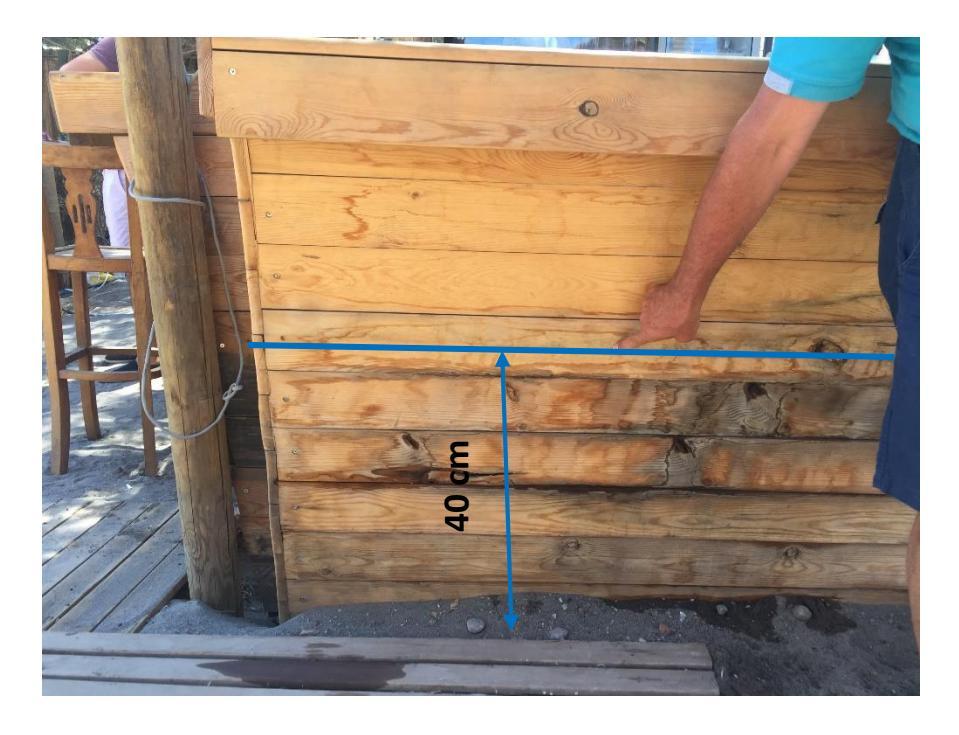
In the second survey, more points in Karaincir Bay were investigated. One of them is La Brezza Beach (15) which is located at western part of the bay. 125 m inundation distance is reported at this beach and 40cm of water level is measured at an elevation of 1.2m with respect to the sea level, for a total of 1.6 m (Figure 4.17).

Figure 4.17: Water level sign observed at La Brezza Beach, western part of Karaincir Bay (27.300179E, 36.969923N)

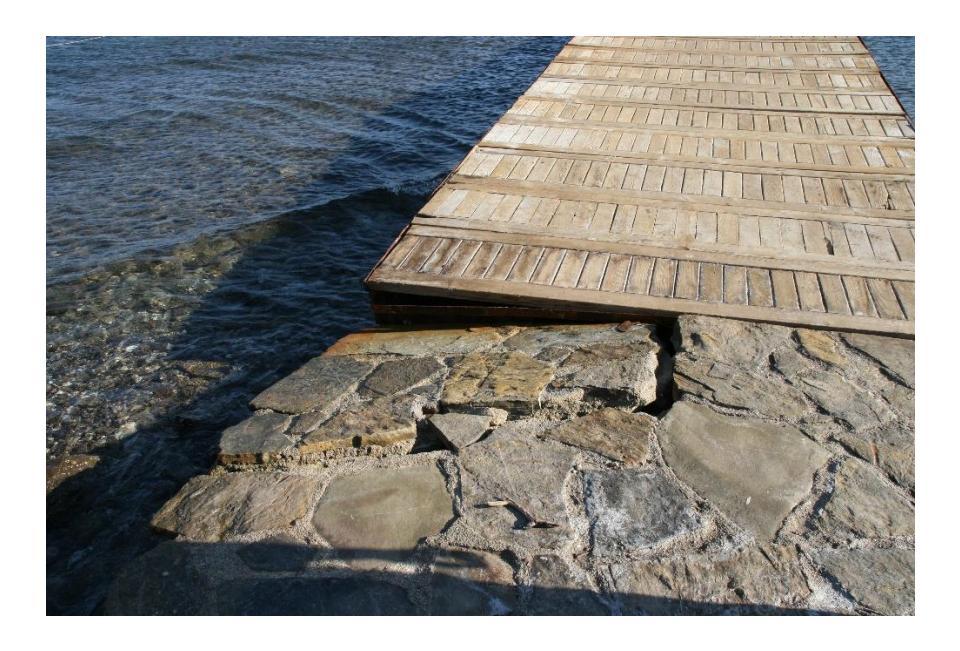
Figure 4.18: Damaged Pier in Aspat Bay (27.312356E 36.979592N)

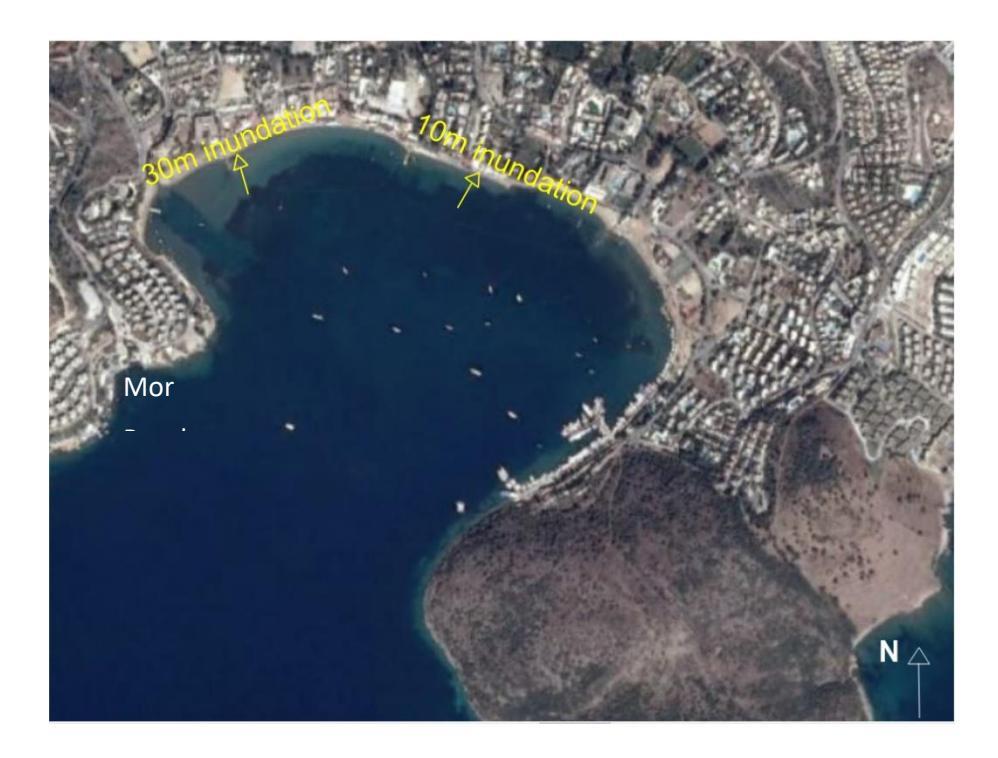
The field survey ended at Bitez Bay (7) of Bodrum where the first motion of the sea is reported as drawdown of 3m, 10-15 minutes after the earthquake. The inundation distance is stated as approximately 10m in the middle of the bay but the eastern part of the bay is more affected by the waves (inundation distance is approximately 30m in this part) due to the location (Figure 4.19). Flow depth is reported as nearly 50cm and no strong current was observed in the bay.

Figure 4.19: Schematic view of wave inundation at Bitez Bay (27.383582E 37.025615N)

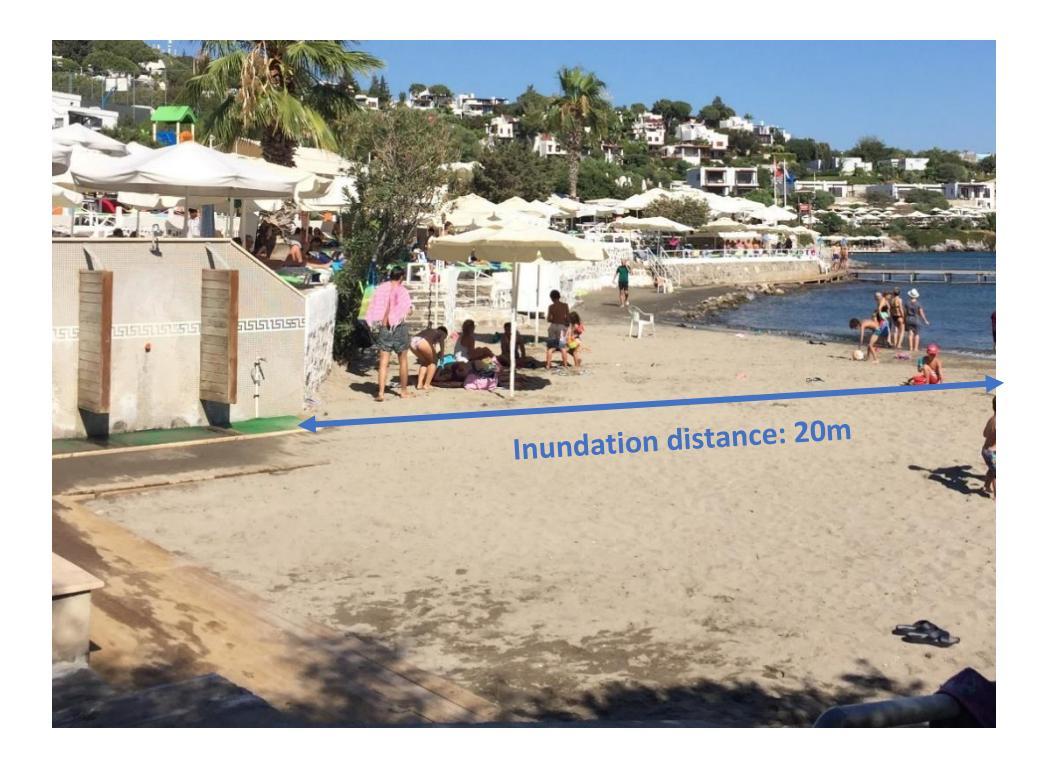
Figure 4.20: Inundation at Aktur Beach (27.366069E 37.02439N)

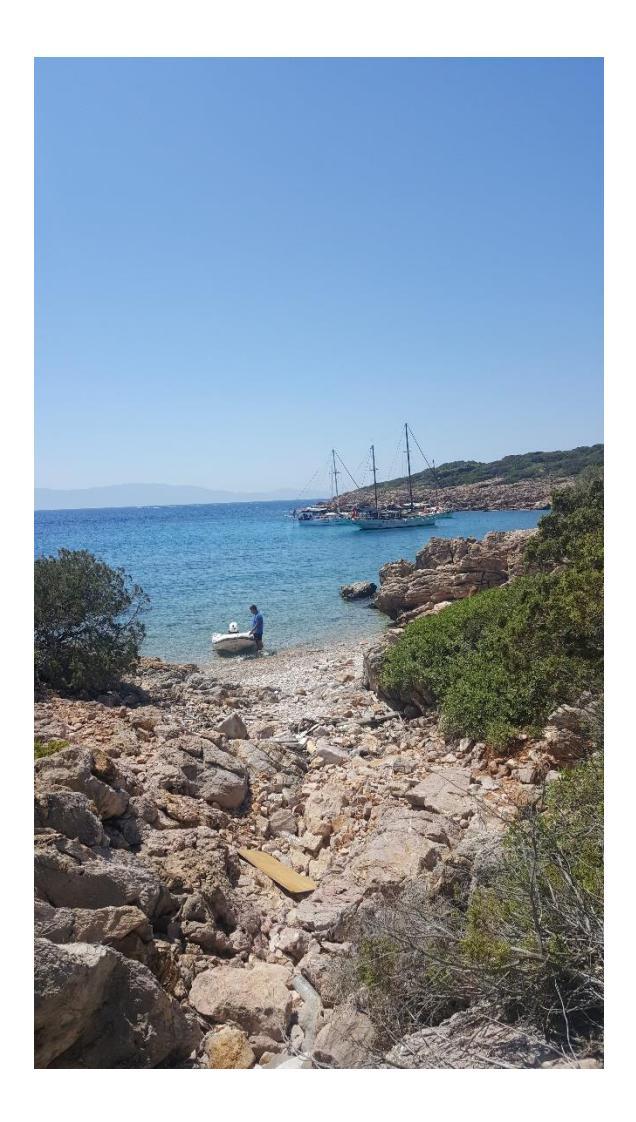
Figure 5.1: Kucukpoyraz Gravel Beach at Karaada (Black Island) a) view from the shore b) view from the beach

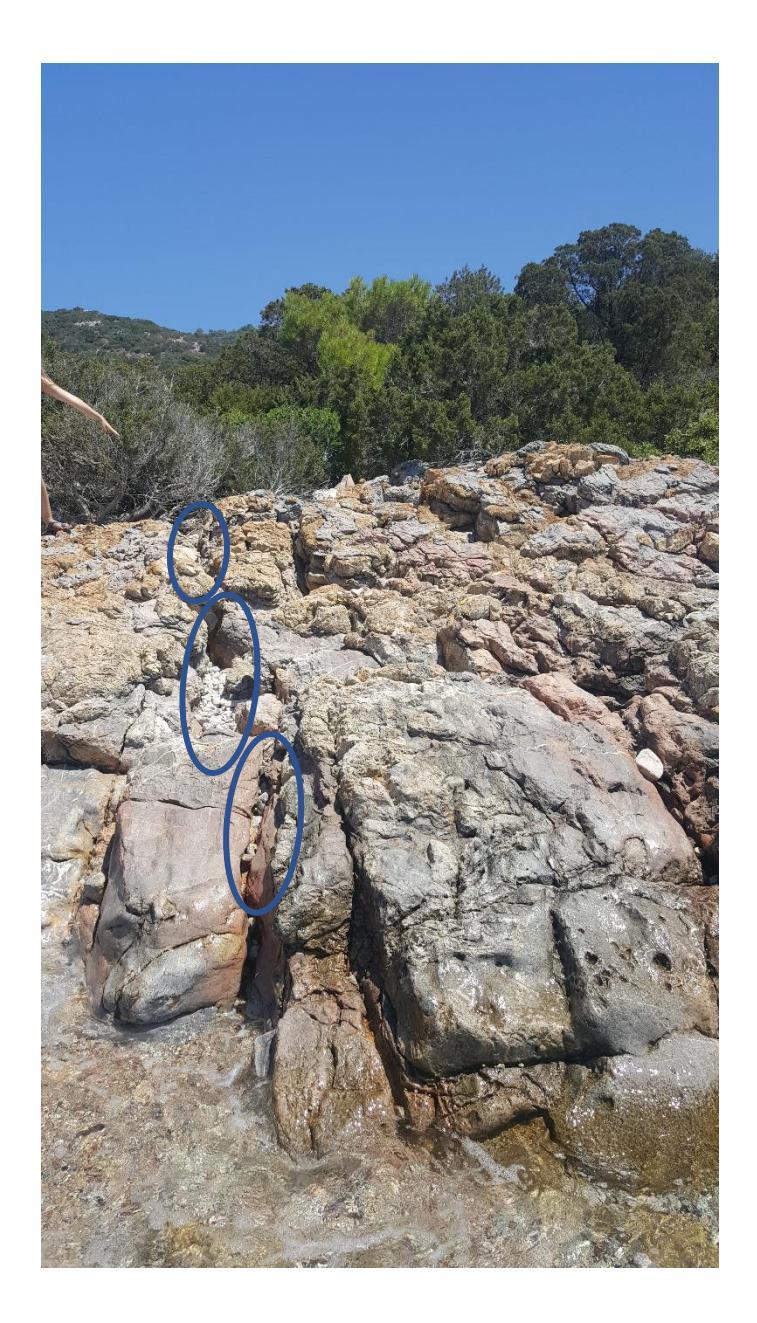
The team visited Kucuk Poyraz beach at Karaada and found small gravels in the spaces on the rocks of the beach which are thought to be washed by the tsunami waves. The elevation that the gravels reached is approximately 2m (Figure 5.2).

Figure 5.2: Small gravels found in the gaps between the rock surfaces at Kucukpoyraz Beach,

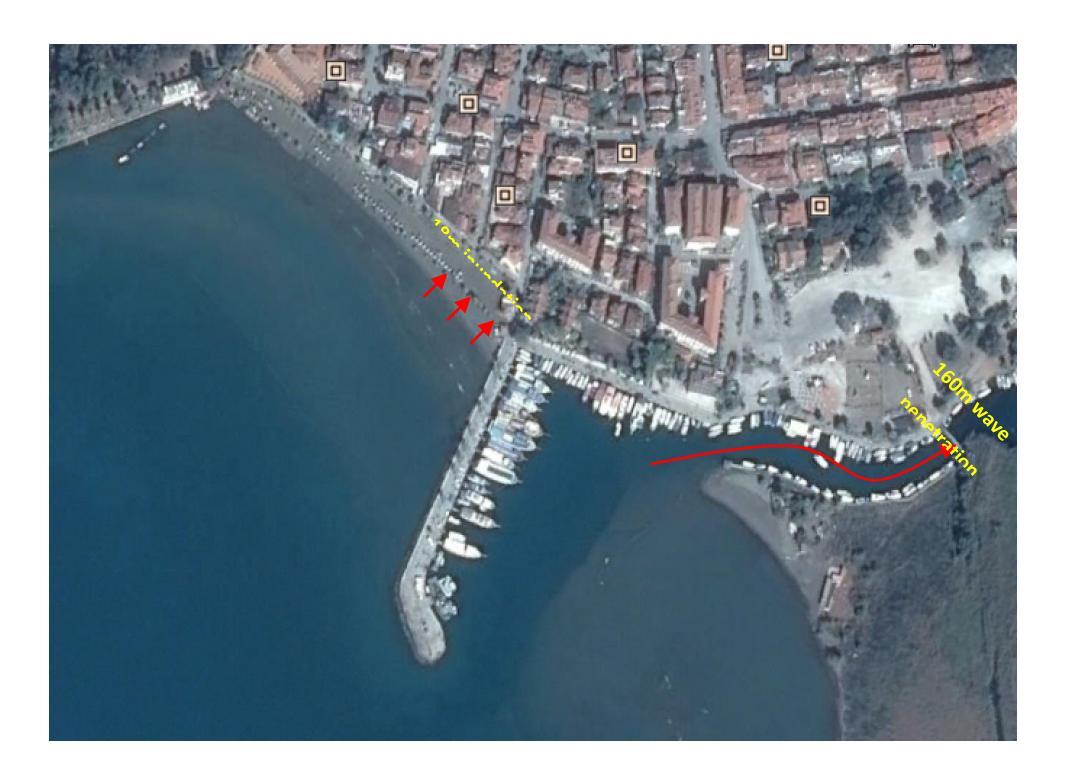
Figure 6.2: Schematic view of wave inundation at Akyaka Beach

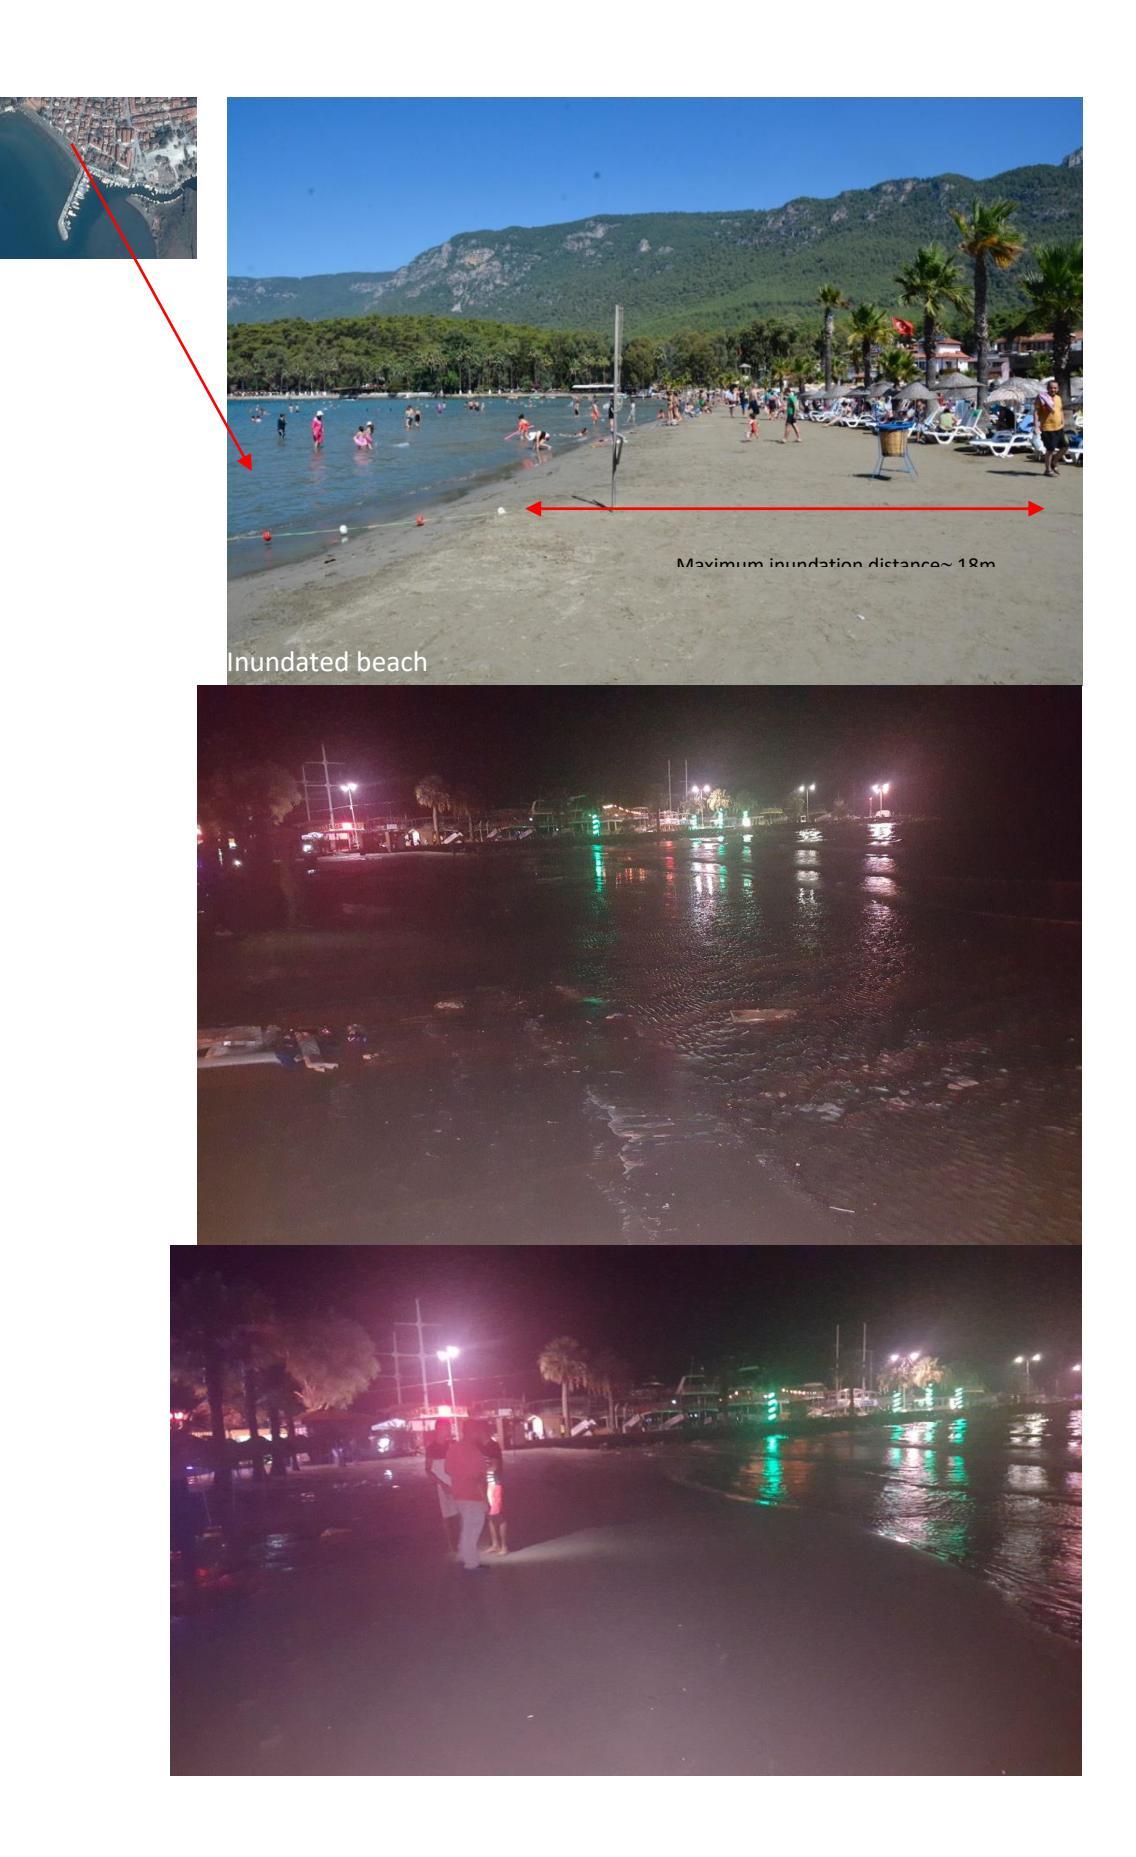
Figure 6.3: Akyaka Beach; original beach condition (above) and the picture shot by an eyewitness after wave inundation (two photos below)

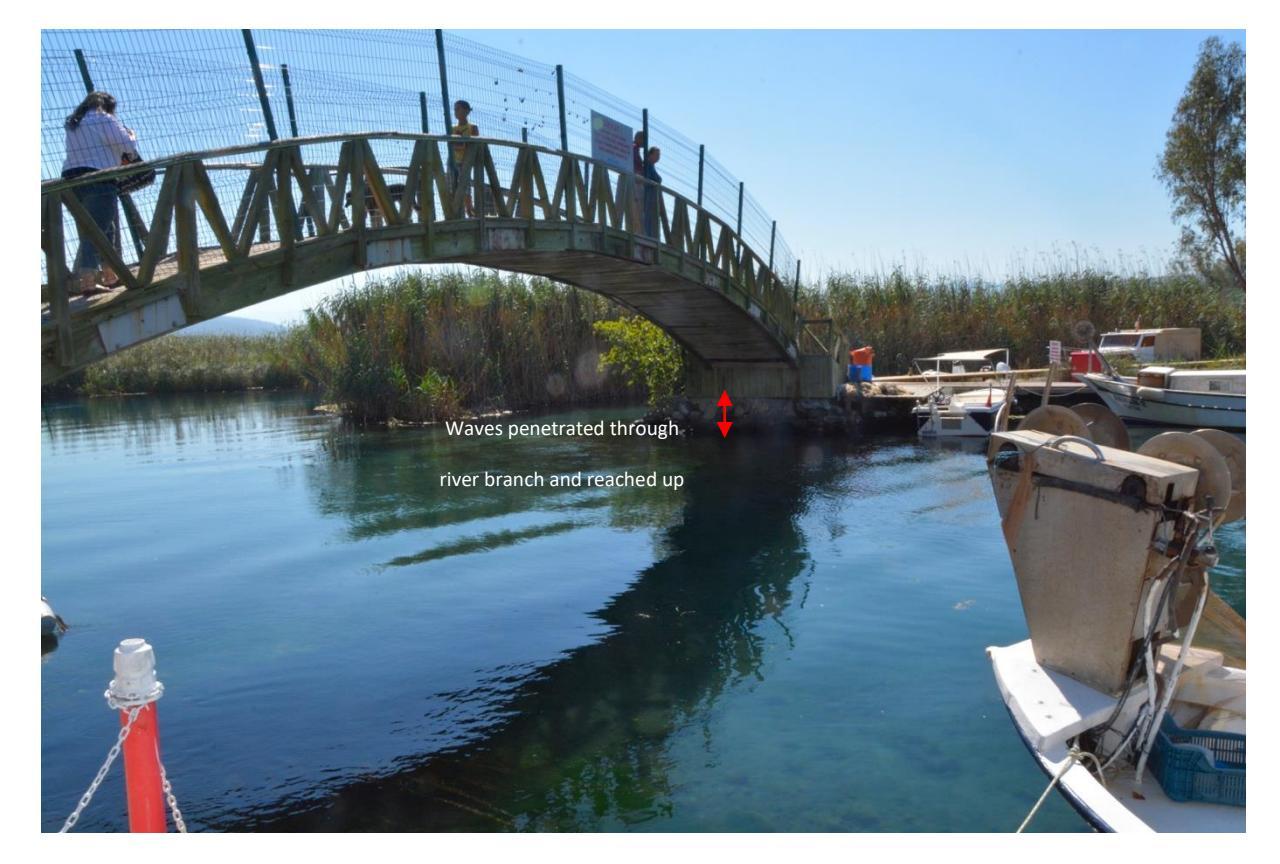
Figure 6.4: Akyaka Stream Branch; waves penetrated through the river up to the first bridge and sea level increased about 60cm

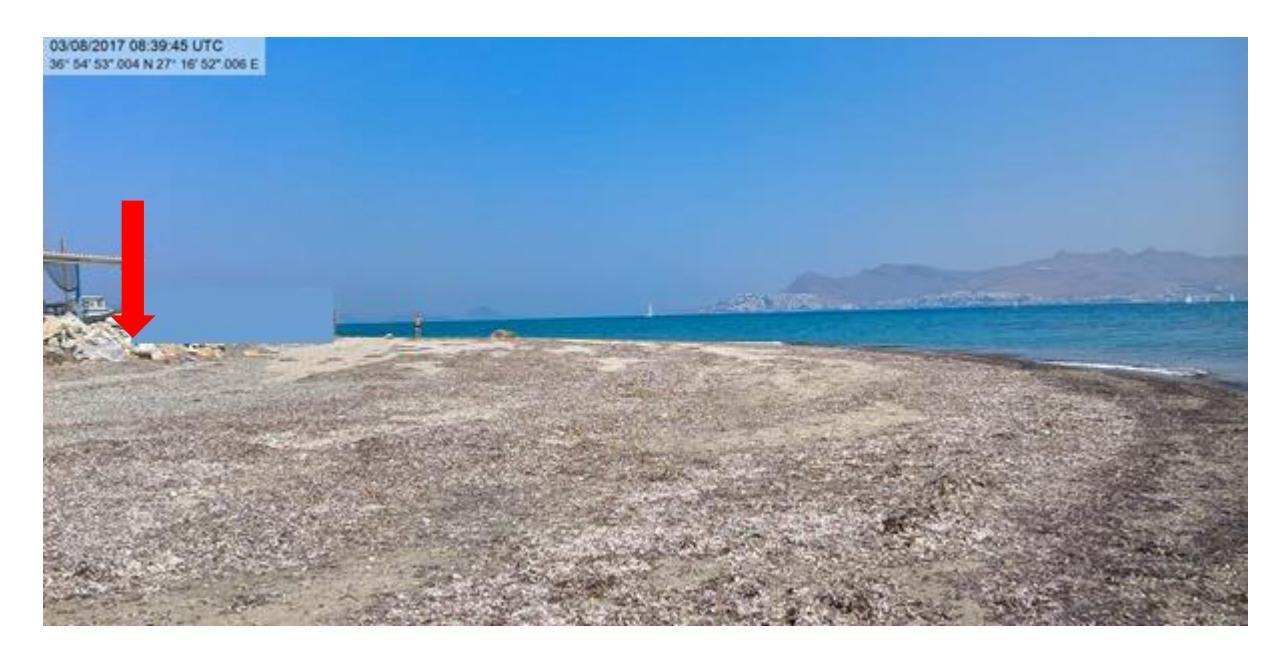
Figure 7.6: The image above, taken at 36.91564 / 27.28037, shows debris close to the shore but an eyewitness reported that the water arrived up to the stones (red arrow). The height measured was 0.6 m, point (7).

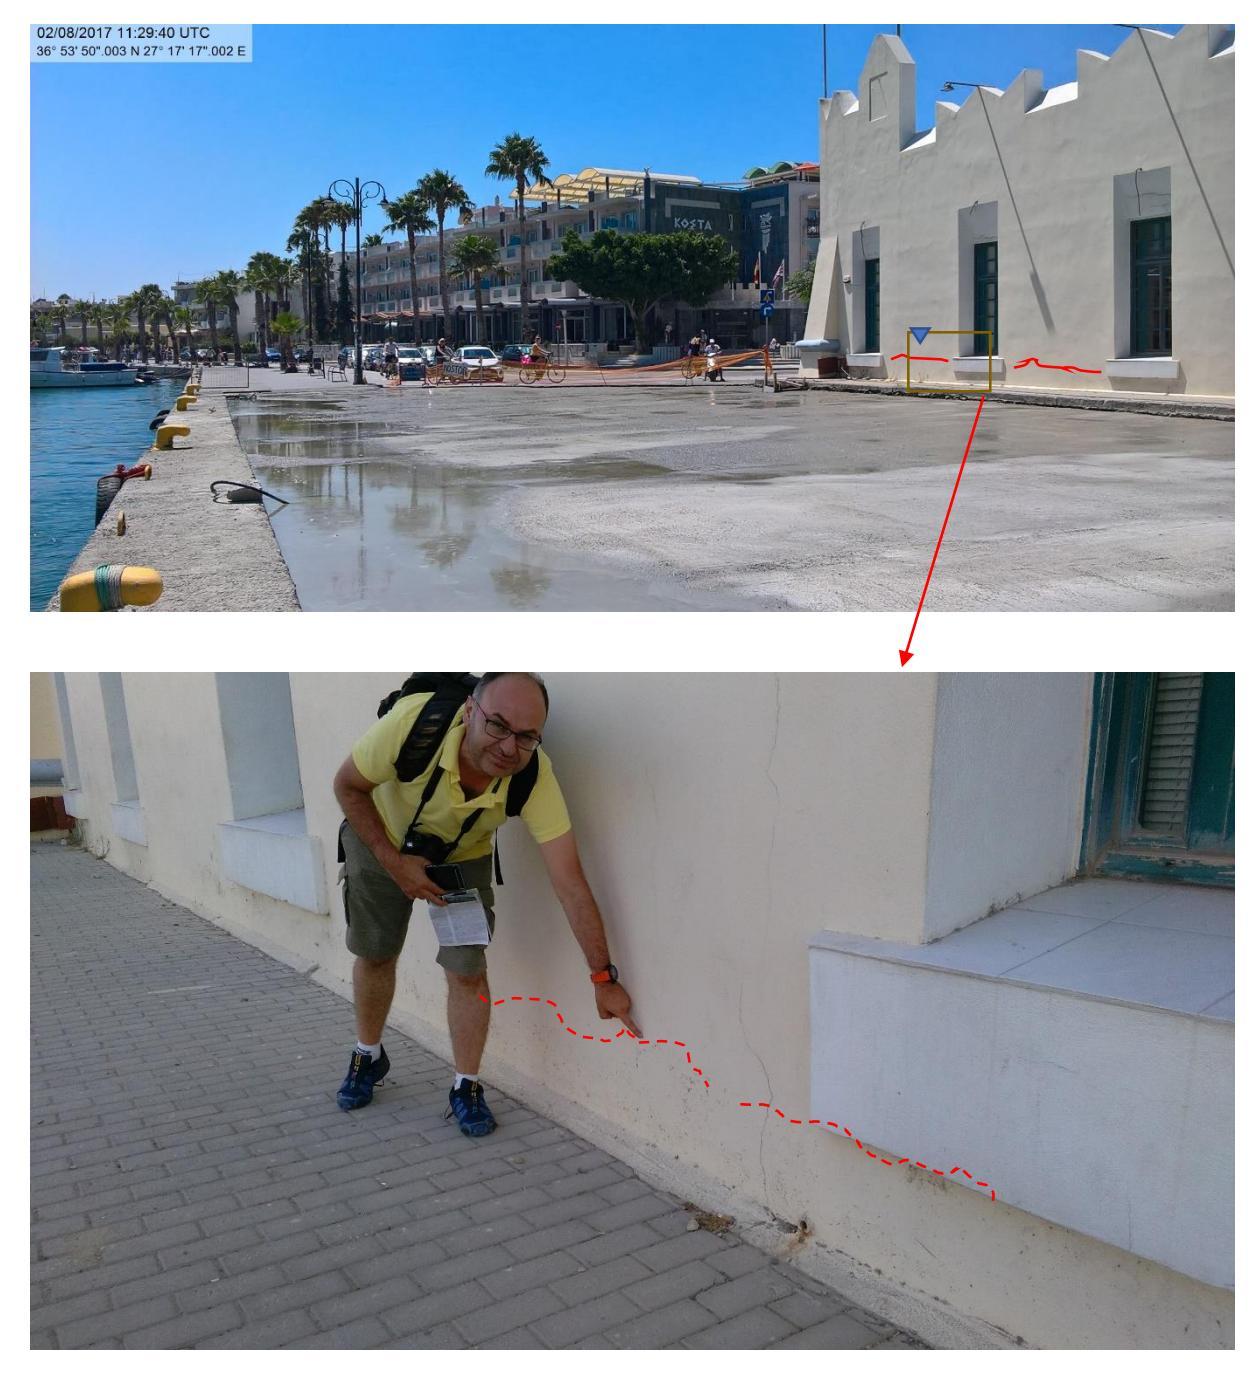
Figure 7.9: Image above was taken at point 36.89745 / 27.28791 and the estimated height is

1.4 m.

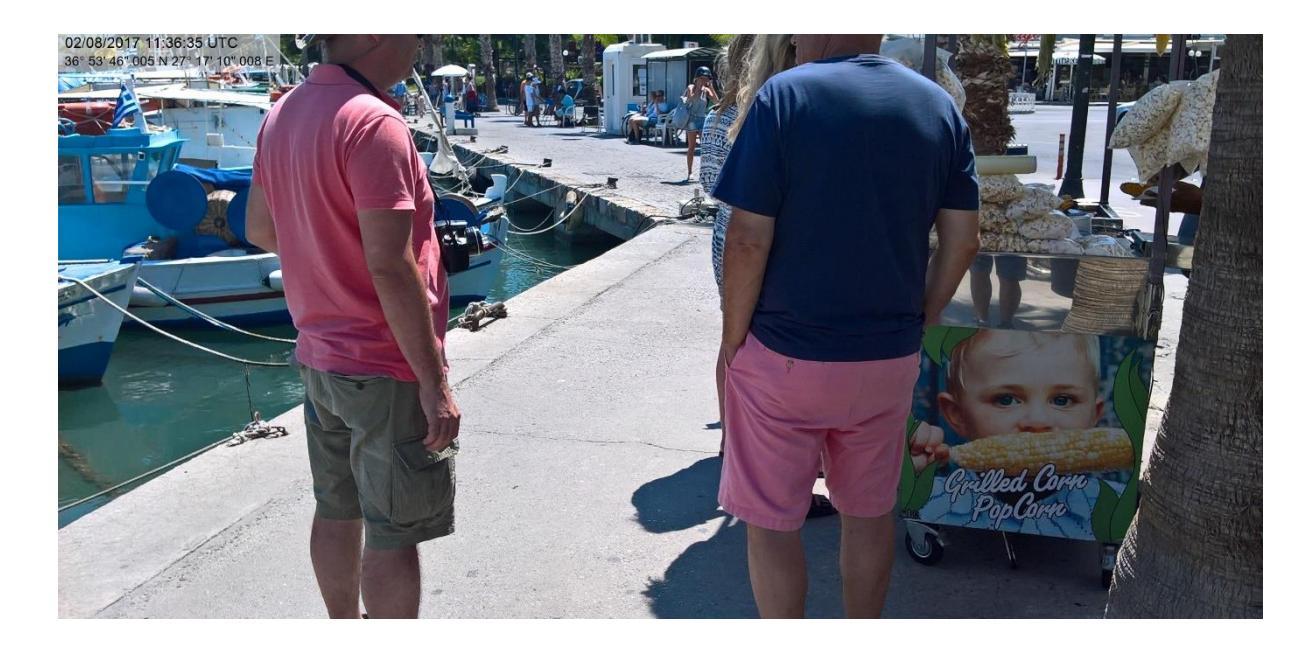
Figure 7.11: Corn panicles seller (36.89626 / 27.28635)

Figure 7.11 is done at 36.89626 / 27.28635, has been reported by the corn panicles seller, who mentioned that his chariot was flooded for about 45 cm. Considering the height of the plane on the water the resulting height was **1.35 m**.
