THE 20th JULY 2017 (22:31 UTC) BODRUM/KOS EARTHQUAKE AND TSUNAMI; POST TSUNAMI FIELD SURVEY REPORT

August 17, 2017 (new version)

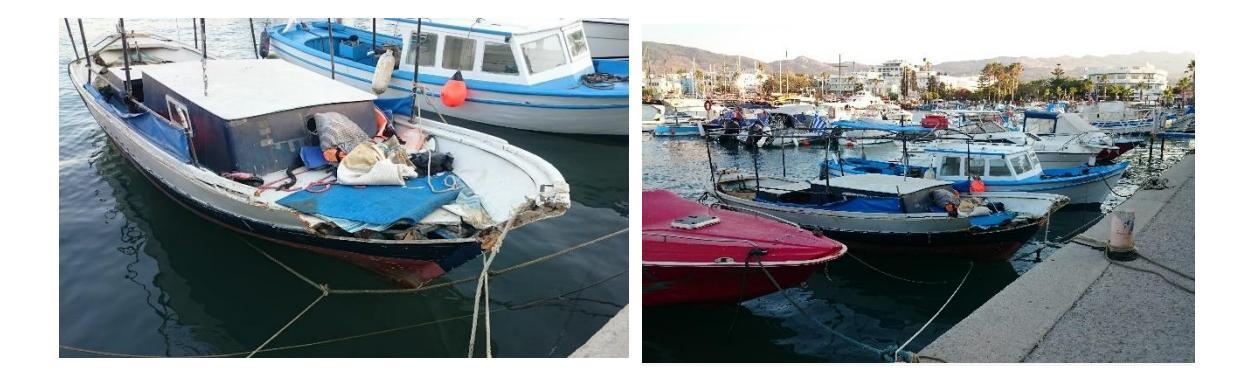
Figure 7.12: Boats damaged due to crashes among the boats, agitated by the tsunami waves or against the trees on the docks

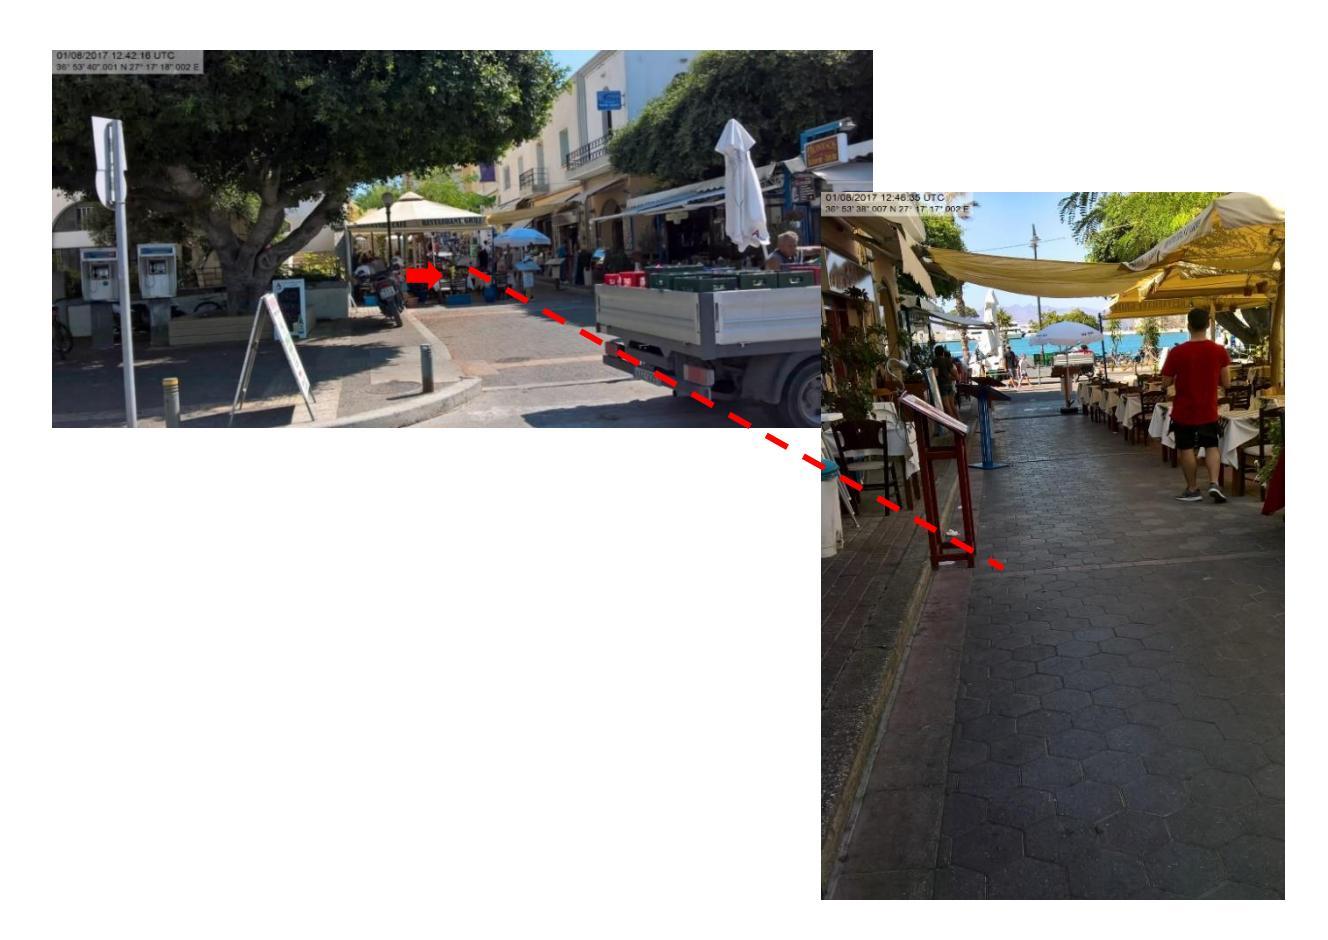
Measurements indicate about **1.5 m** from sea level. It should be noted that this road is in front of the port mouth and therefore some larger wave height should be expected.

Figure 7.13: Ioanidi road flooded with sea water up

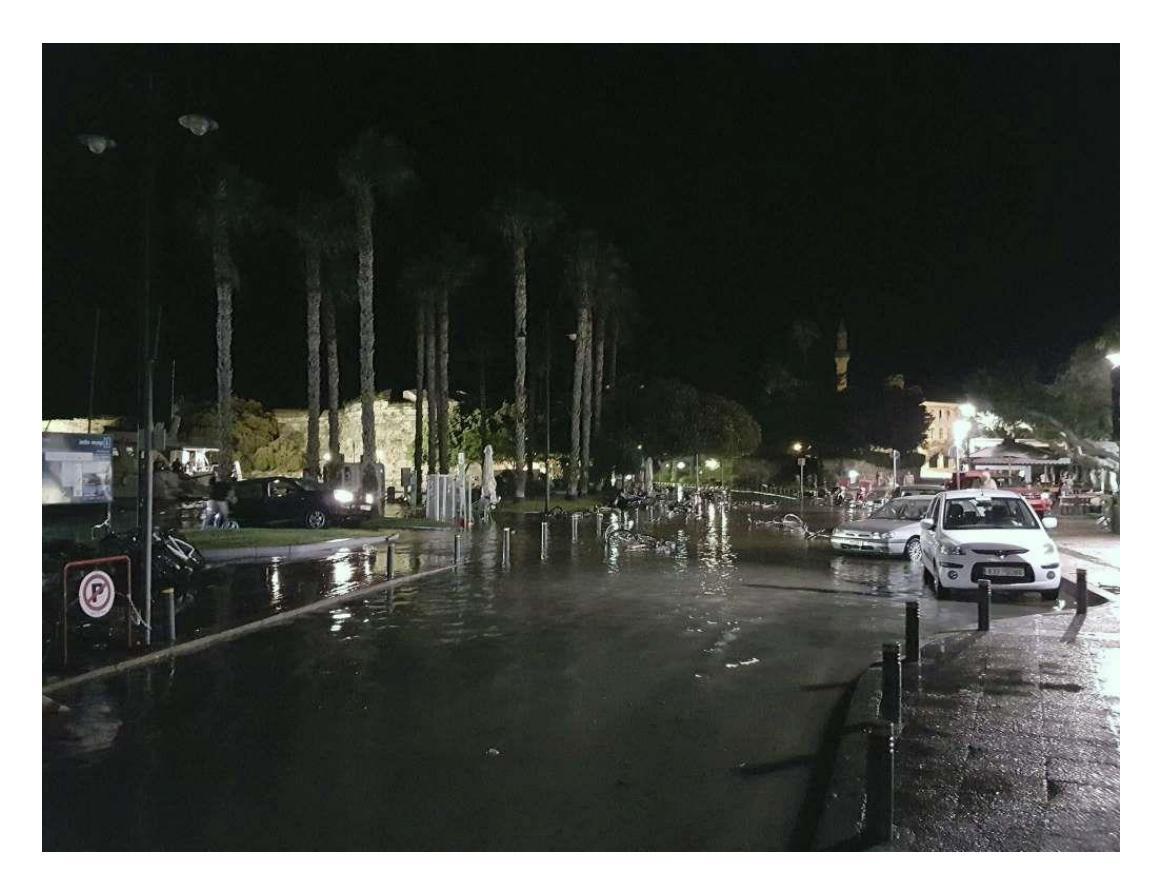
Figure 7.16: Cars drifted by the tsunami in Port of Kos, near the "Bridge" point (photo credit

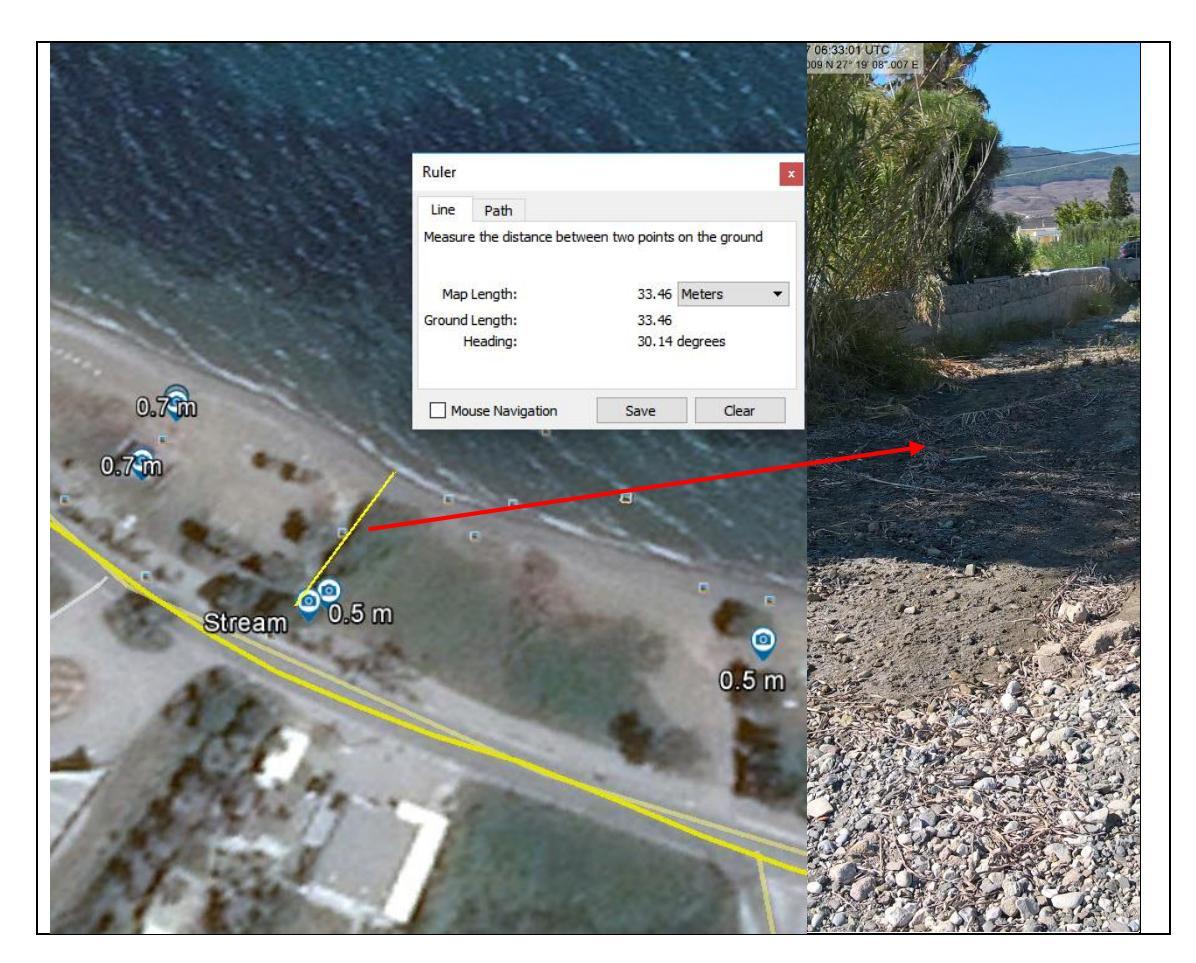
Figure 7.21: Water penetration along Leoforus Papandreu Georgiou (location 14)

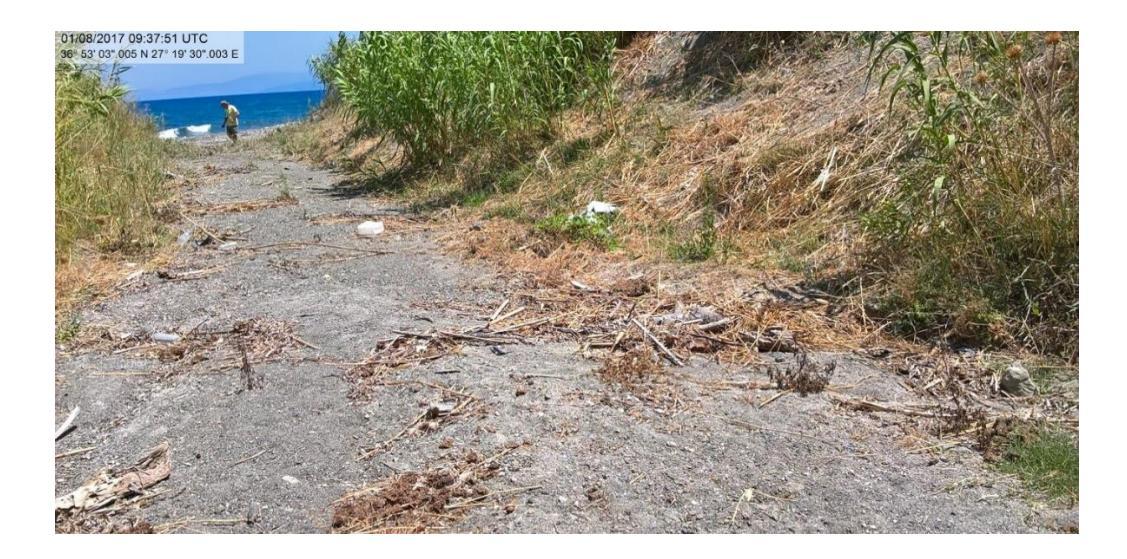
Figure 7.22: The stream at location (15) where the presence of several possibly tsunami deposits were observed.

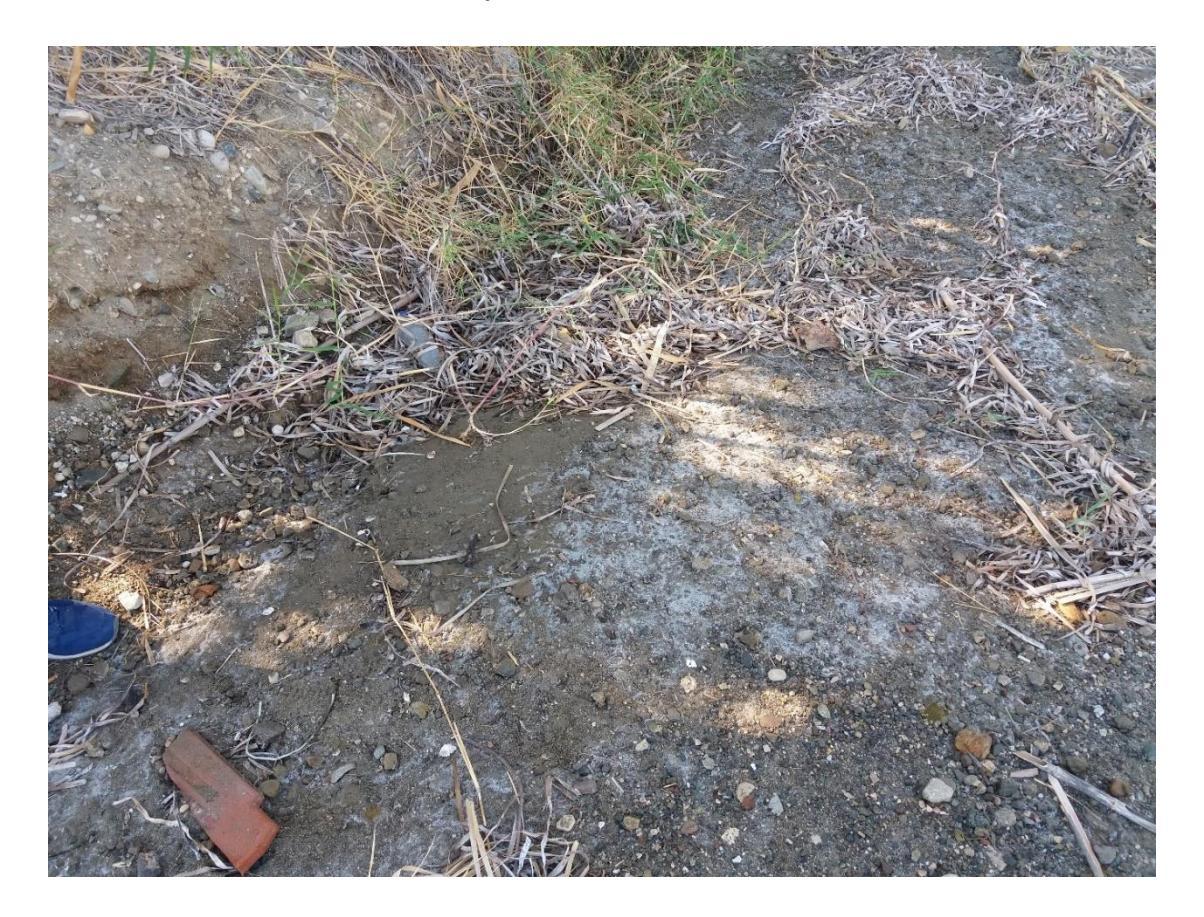
Figure 7.23: Salt remnants at the floor of the stream at location (15).

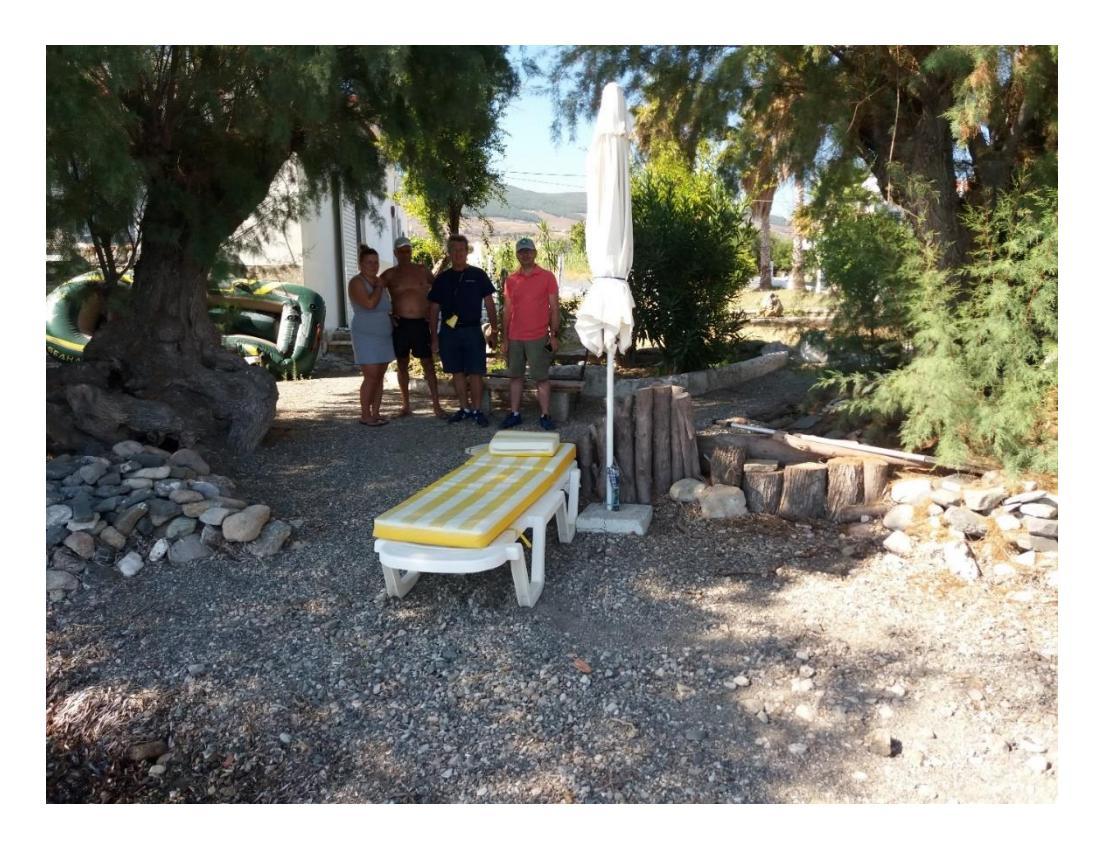
Figure 7.24: A couple (left hand side) at location (15) verified the tsunami inundation by ~15 m in their household place.

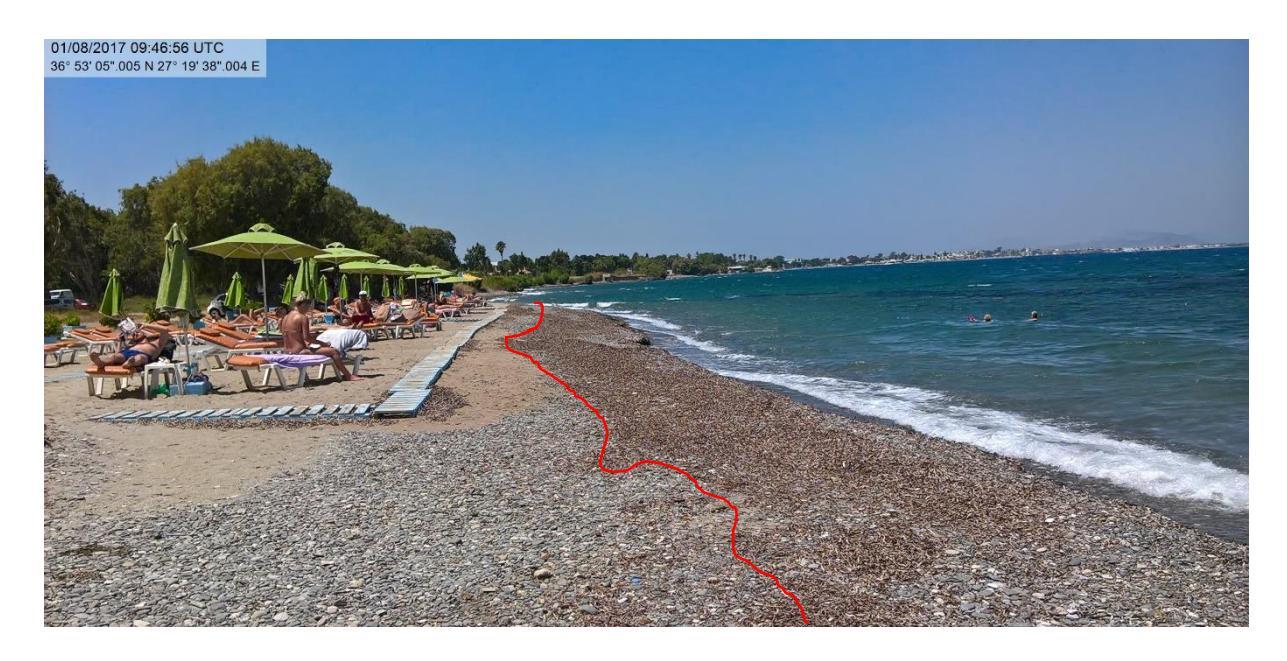
Figure 7.25: The line of deposits quite close to the shore, with about 0.5 m of height above the water.

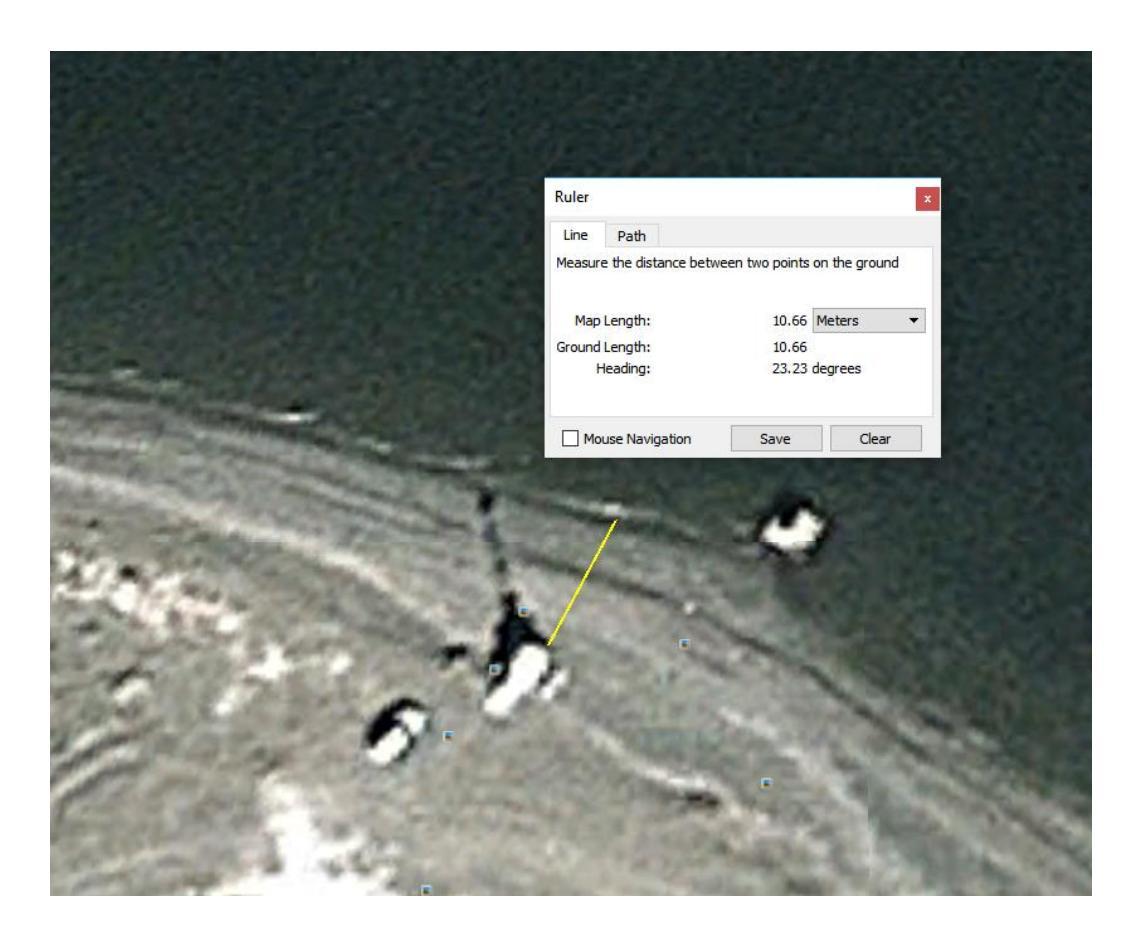
Figure 7.27: Basement of the antenna at the shoreline

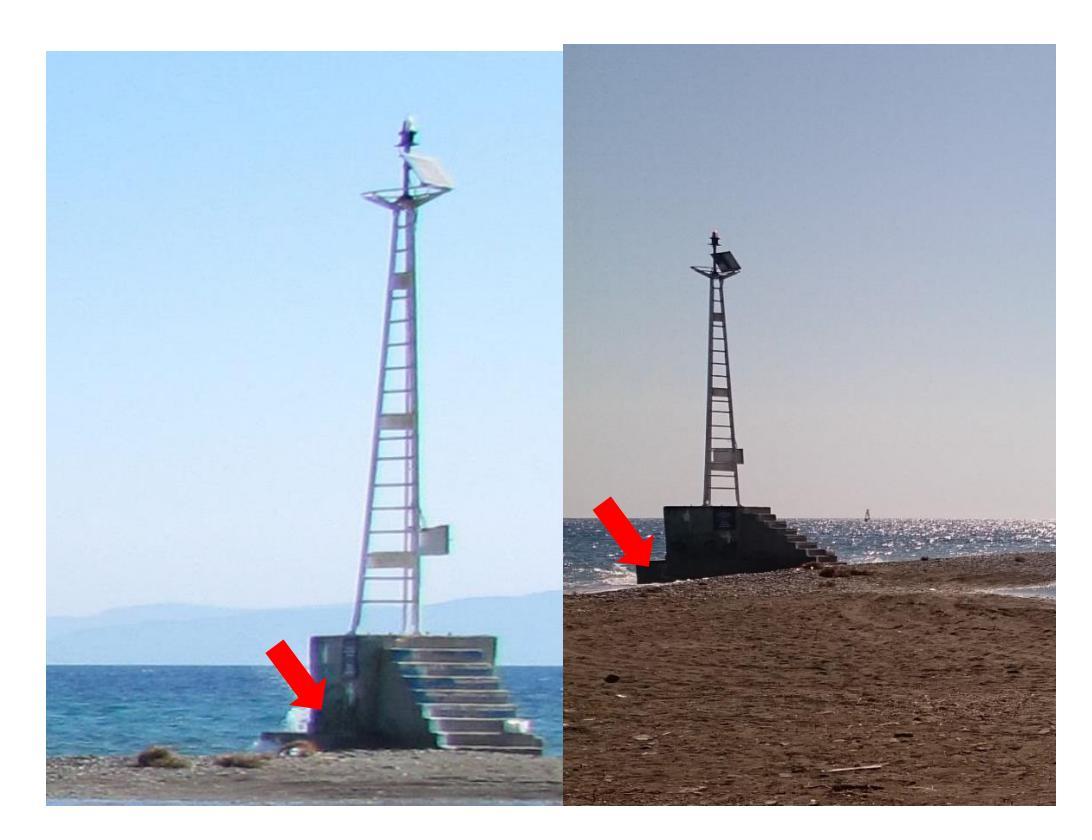
Close to the cape other interesting phenomena of ground failures occurred. Note that the ground in this area is soft consisting by sea sand mixed up with gravels of various sizes. People managing the local wind surf stand reported that the day after the earthquake their stand was found within a local lake formed apparently due to the earthquake. The lake was still existing on 2nd August 2017 during our visit, while the area around the lake "bank" was wet. The people removed their stand further but one small kiosk remained at the edge of the lake. The lake is roughly of elliptical shape with its major axis being of ~20-25m in length and the minor of ~10m in length. It was also reported that in about the center of the lake a ground hole of ~1m deep opened, while similar holes opened in the nearby area but they closed by the wind surf people. The lake side facing the lighthouse-antenna stand lies at distance of ~ 10m from the seashore. At the perpendicular direction, the distance of the lake from the seashore is at ~50-60 m. Then, tsunami inundation does not account for the lake creation.

An alternative is the local subsidence that may have occurred in the Cape Louros due to the earth shaking with the large earthquake. Subsidence evidence comes from the observations at the lighthouse-antenna place, as reported above. In addition, the Mayor of Kos Mr George Kyritsis told us that two scuba divers reported to him that the sea floor around Cape Louros had deepen significantly after the earthquake. Local subsidence may have caused the very shallow water table to expose above the surface thus creating the local lake.

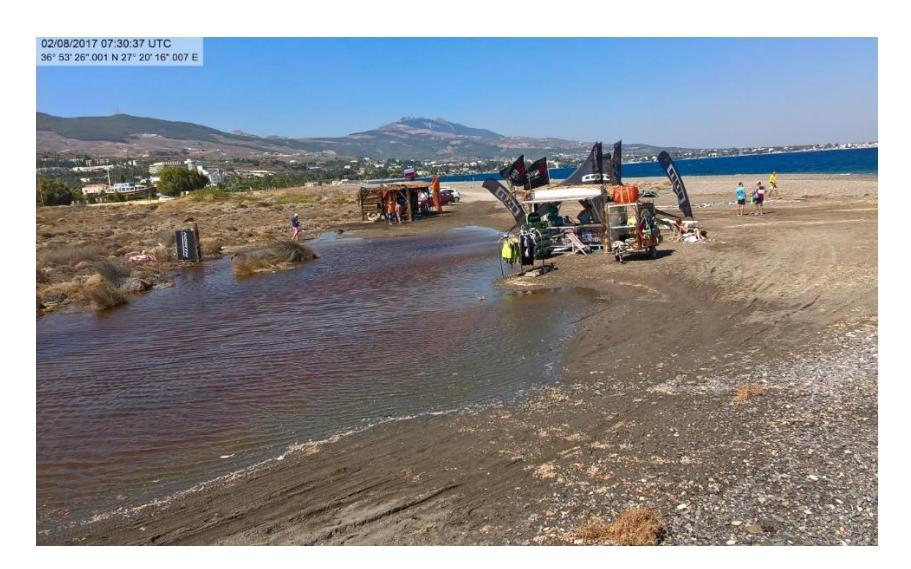
Figure 7.28: The lake as seen from the lighthouse-antenna stand. The liquefied area is at the left side. The distance to the right side is ~50-60 m. A small kiosk of the wind surf stand remained at the left edge of the lake.

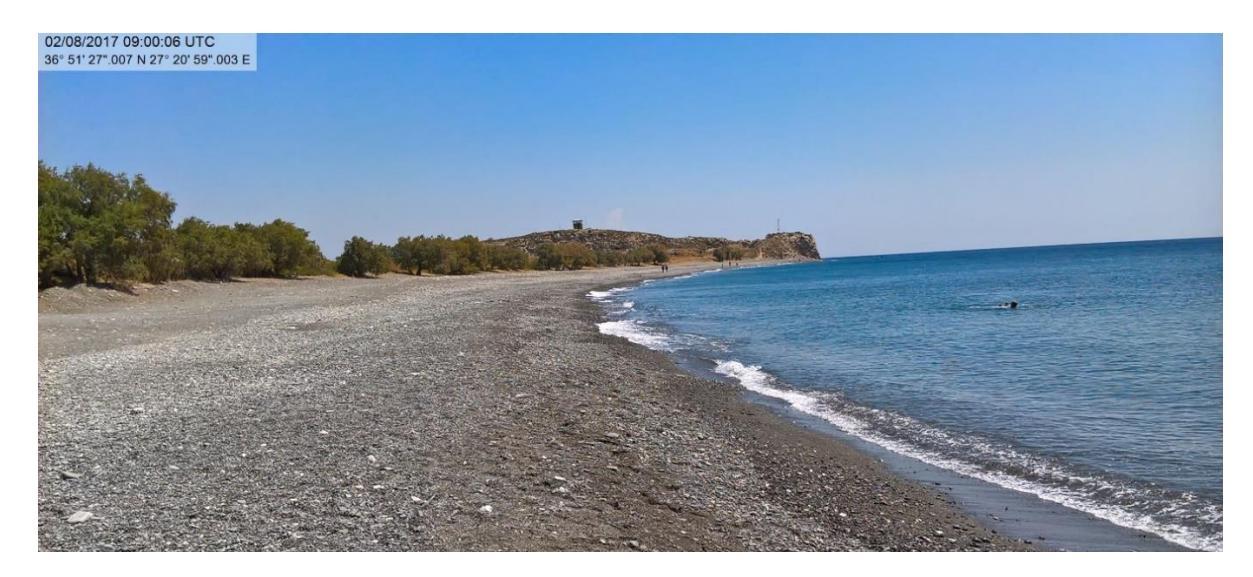
Figure 7.31: Point (21) that showed no sign of tsunami

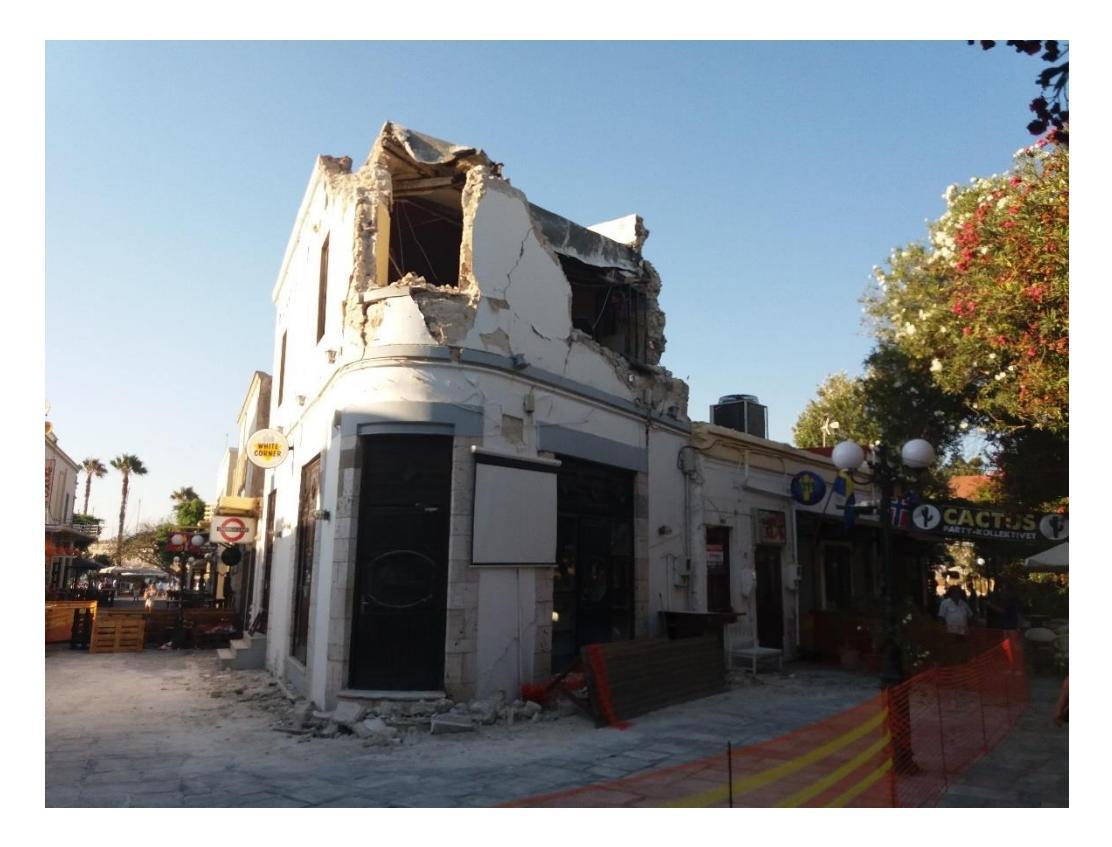
Figure 7.32: Damaged building at Kos in the old part of Kos City

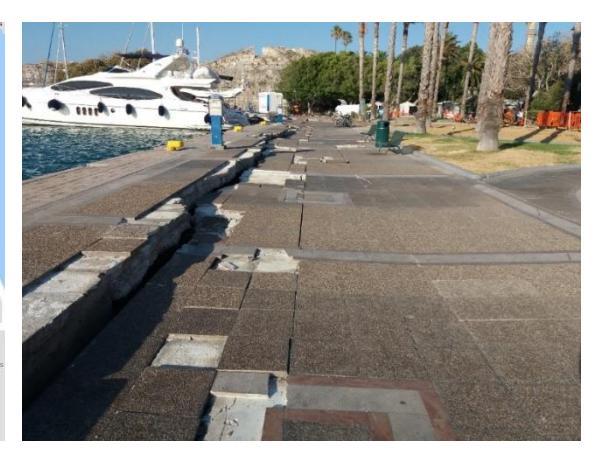
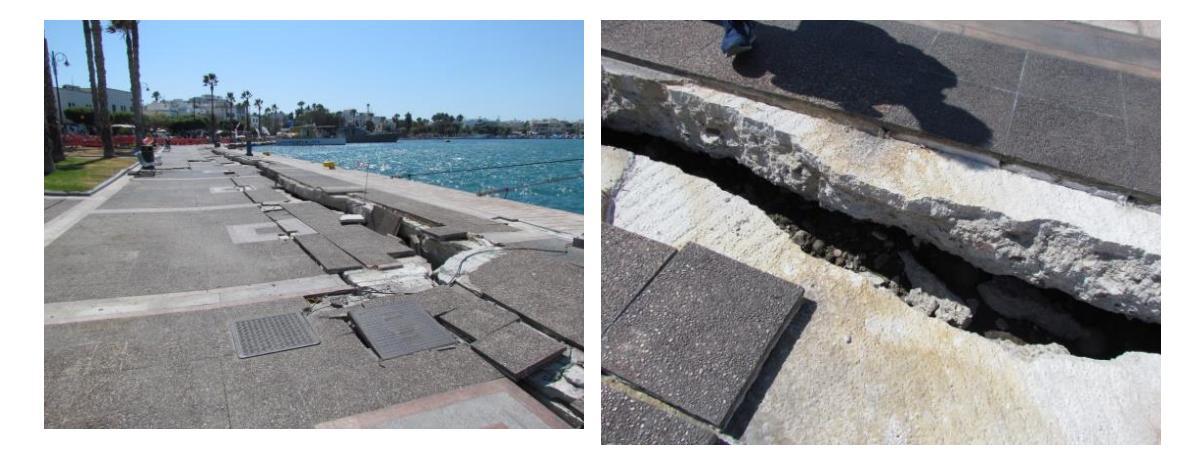
Figure 7.33: A) Damage line at the dock of port B) Damage at the dock of port C) Damage at the dock of port D) Distancing of the materials of the dock

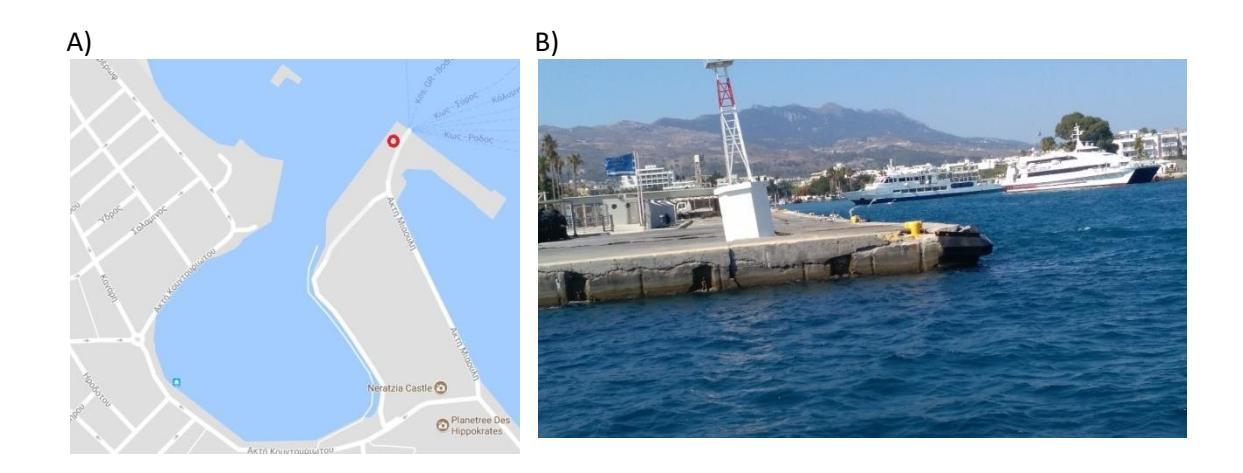
Figure 7.34: Failure on the ground of the lighthouse were occurred by the strong shaking of the earthquake and structural problems of the dock. A) Location of the light house B) Port structure deformation due to the earthquake

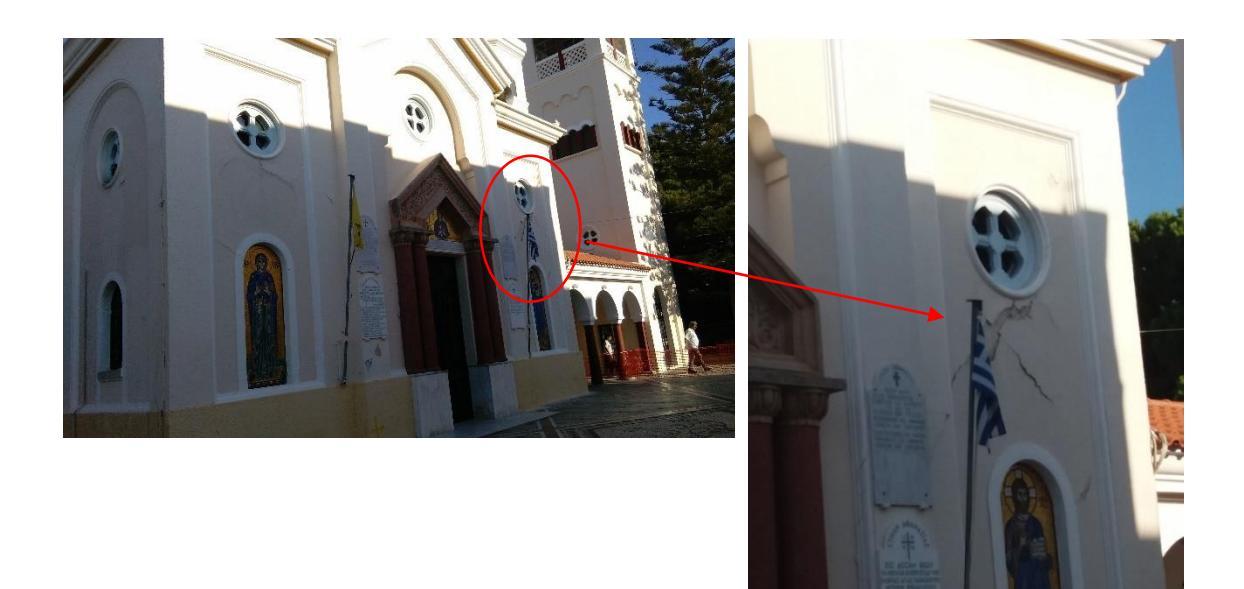
Figure 7.35: The church of Agia (St.) Paraskevi (old part of the Kos city) damaged and rendered temporarily unusable.

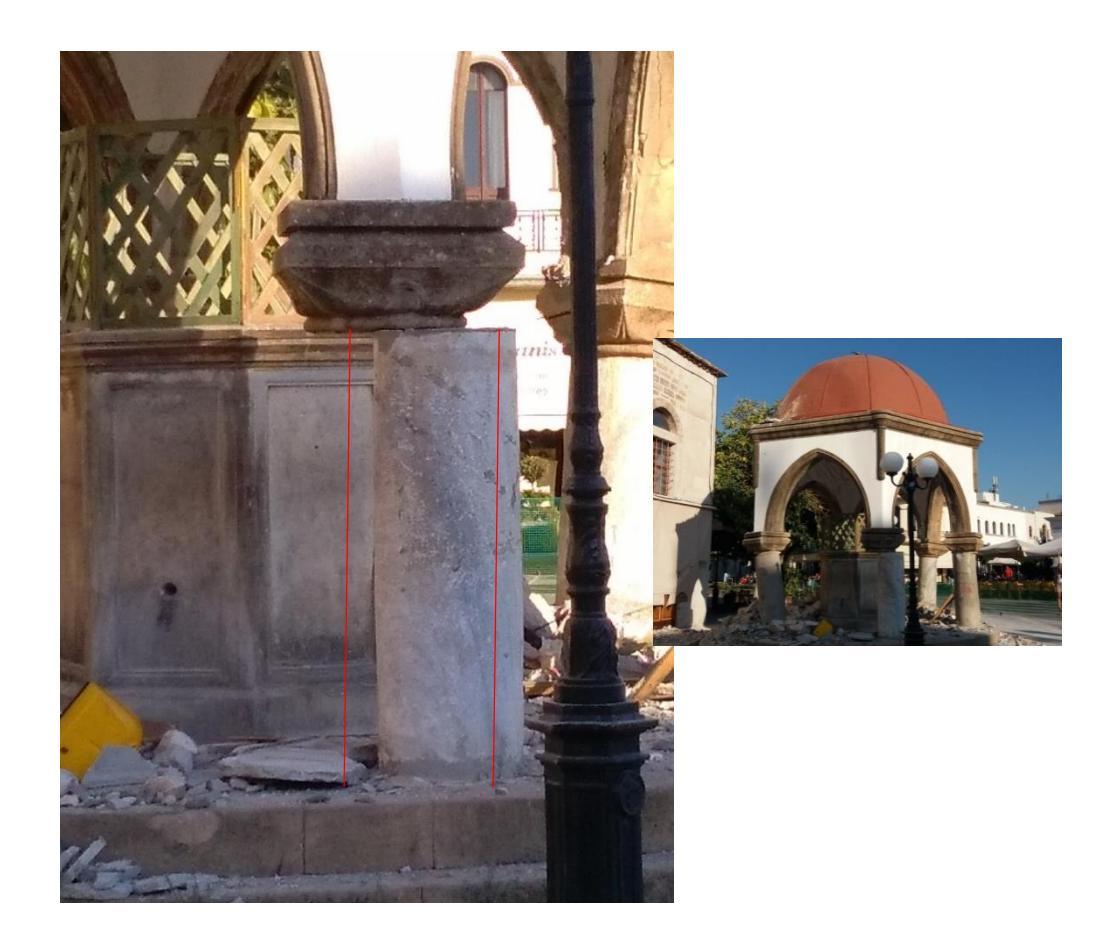
Figure 7.37: One fountain of Mauritanian style, situated next to the Defterdar Mosque (old part of the Kos city) damaged due to the strong earth shaking but also because the Mosque minaret fell on it. Please note the change of the relative position between the column and the roof structure (red lines).

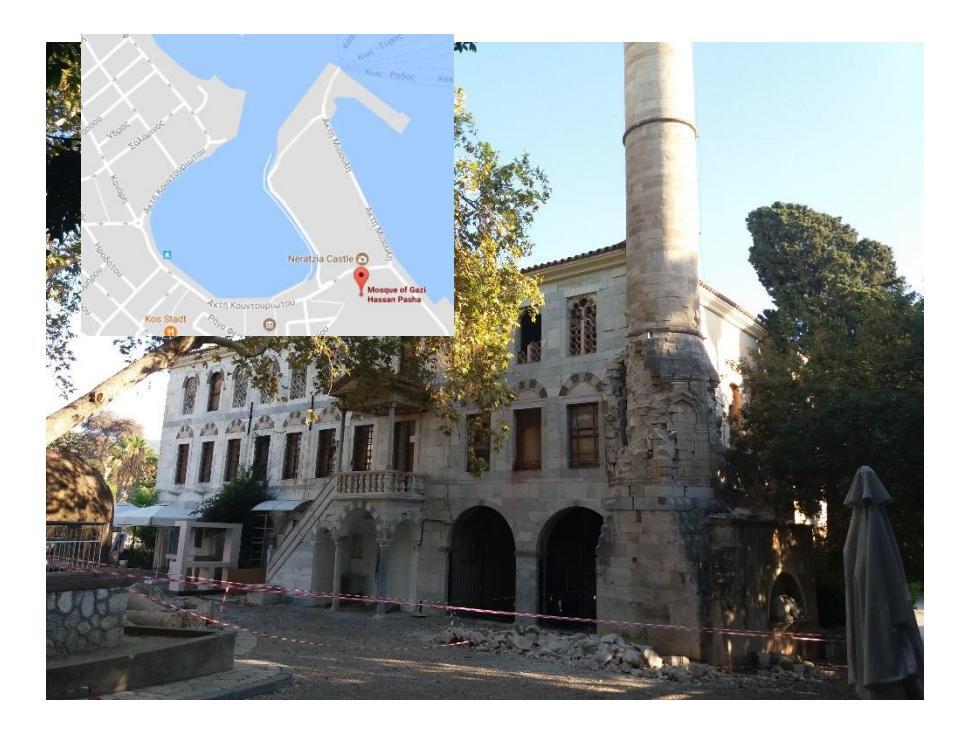
Figure 7.38: The minaret of the Gazi Hasan Pasha Mosque (old part of the Kos city) was damaged at its base. The Mosque building also damaged.

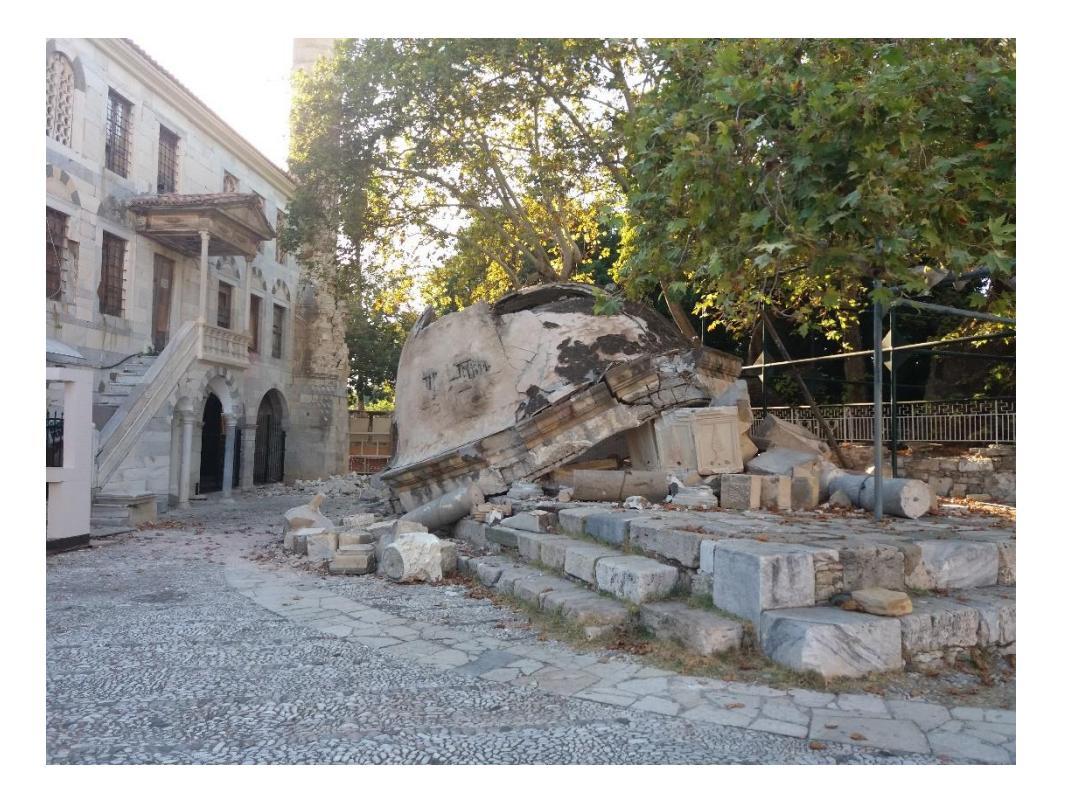
Figure 7.39: One fountain of Mauritanian style, situated next to the Gazi Hasan Pasha Mosque (old part of the Kos city) was completely collapsed.

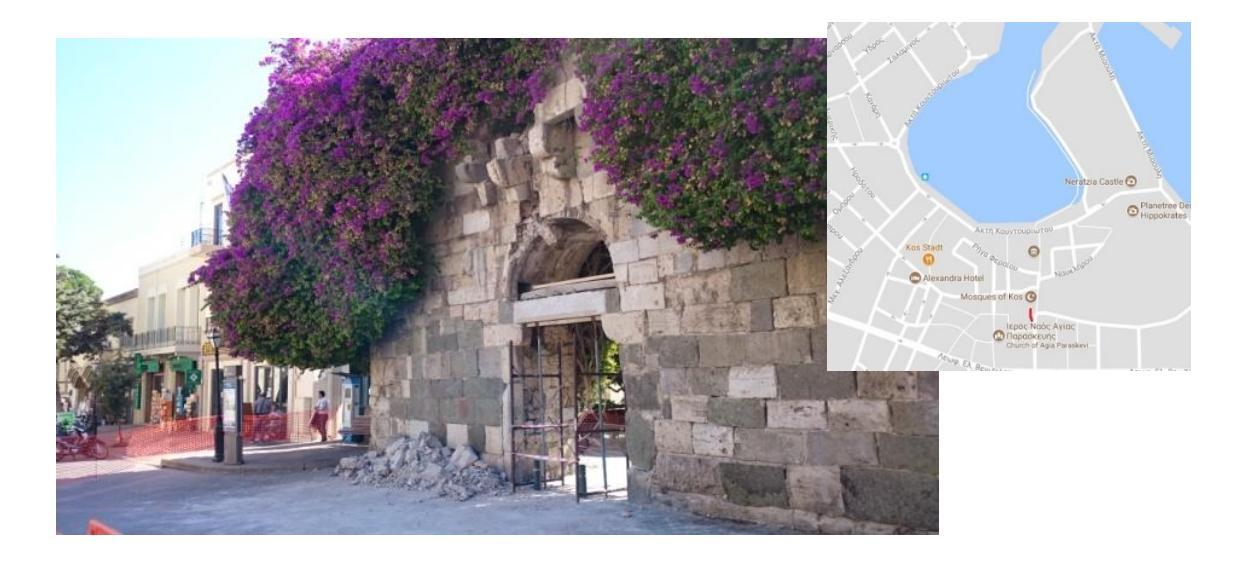
Figure 7.40: Damages occurred to a number of historical building from Roman time in
