THE 20th JULY 2017 (22:31 UTC) BODRUM/KOS EARTHQUAKE AND TSUNAMI; POST TSUNAMI FIELD SURVEY REPORT

August 17, 2017 (new version)

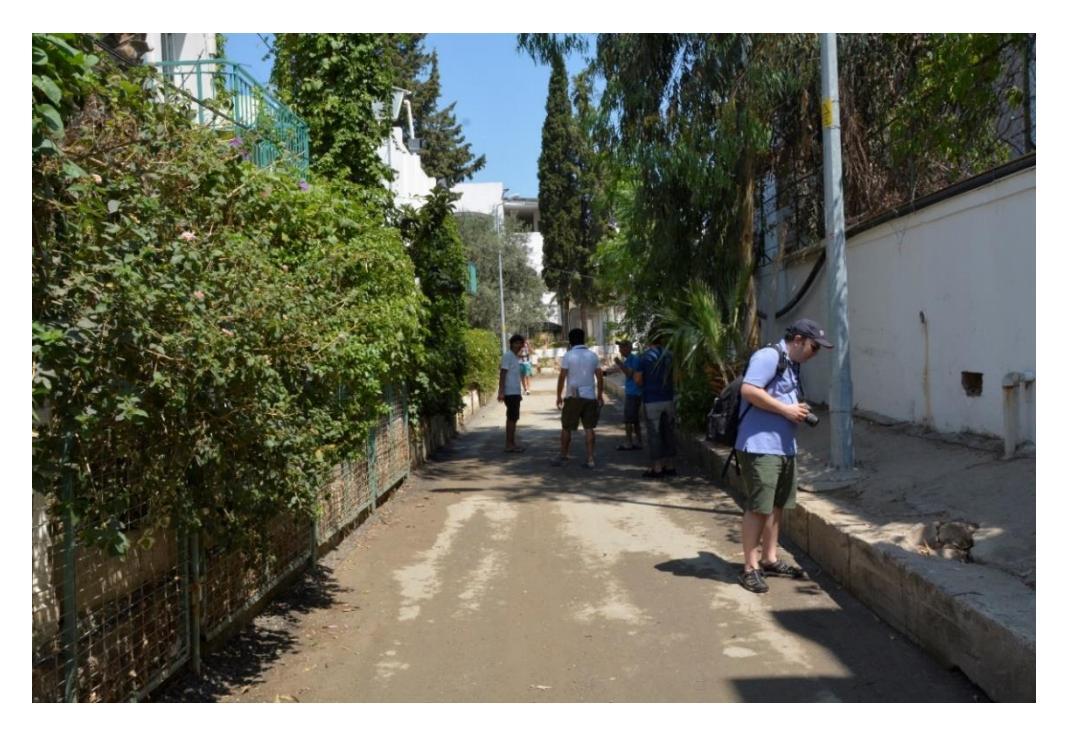
The waves mostly penetrated through the dried stream bed (used as a road and parking place) near Ayaz Hotel (Figure 4.3). The width of the road is 3.3 meters (5.7 meters with side walls). The waves penetrated through this stream bed, accelerated as flowing in a channel and reached up to 100m away from the shoreline. The maximum flow depth in the stream bed was around 0.85 m (Figure 4.4). According to the security camera records of a hotel, waves reached to the entrance door of hotel about 13min after the earthquake. The tsunami inundation distance is about 60 meters and flow depth reached up to 0.5-0.6m. Waves flew in strong current in hotel front.

Figure 4.3: Penetration of the waves through the dried stream bed near Ayaz Hotel

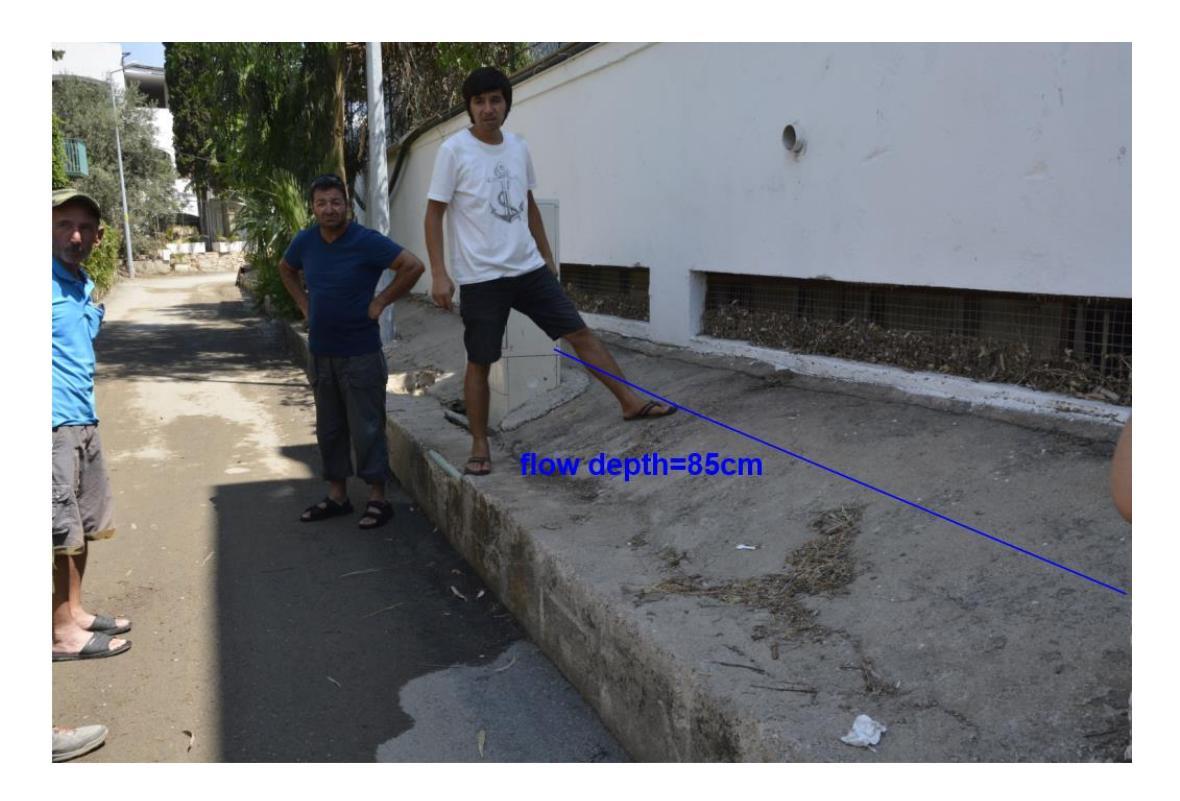
Figure 4.4: Observer showing the flow depth by his foot (37.031412N 27.406703E)

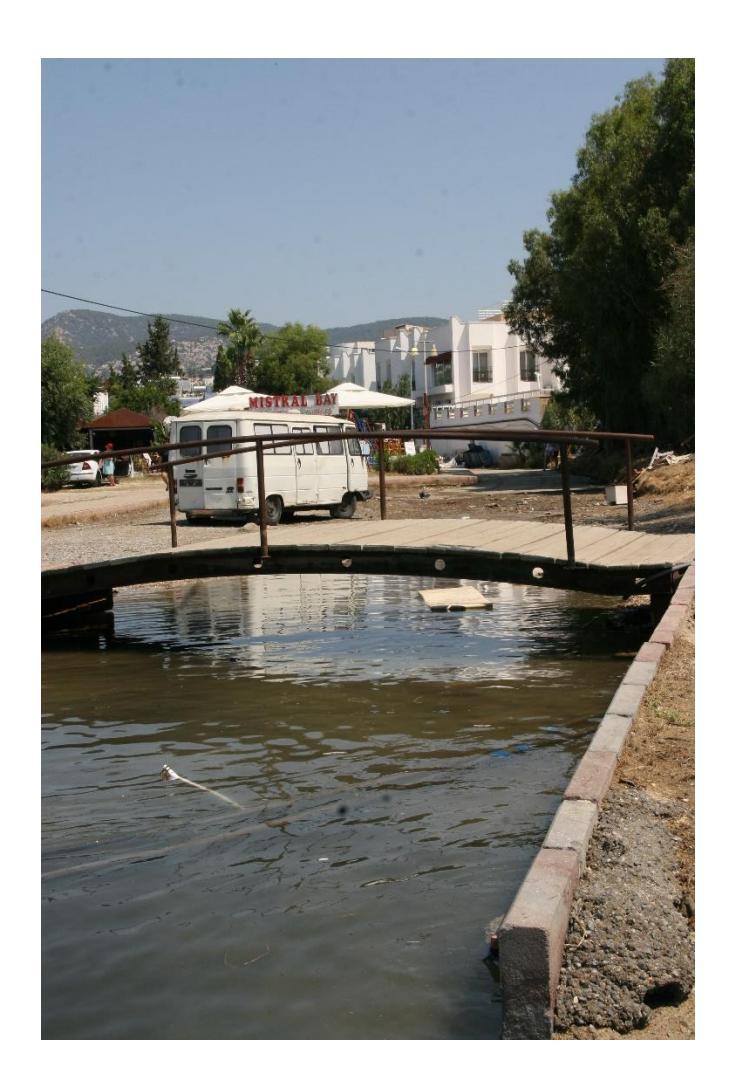
Figure 4.5: View of the stream bed that the tsunami inundated (27.407821E 37.029761N)

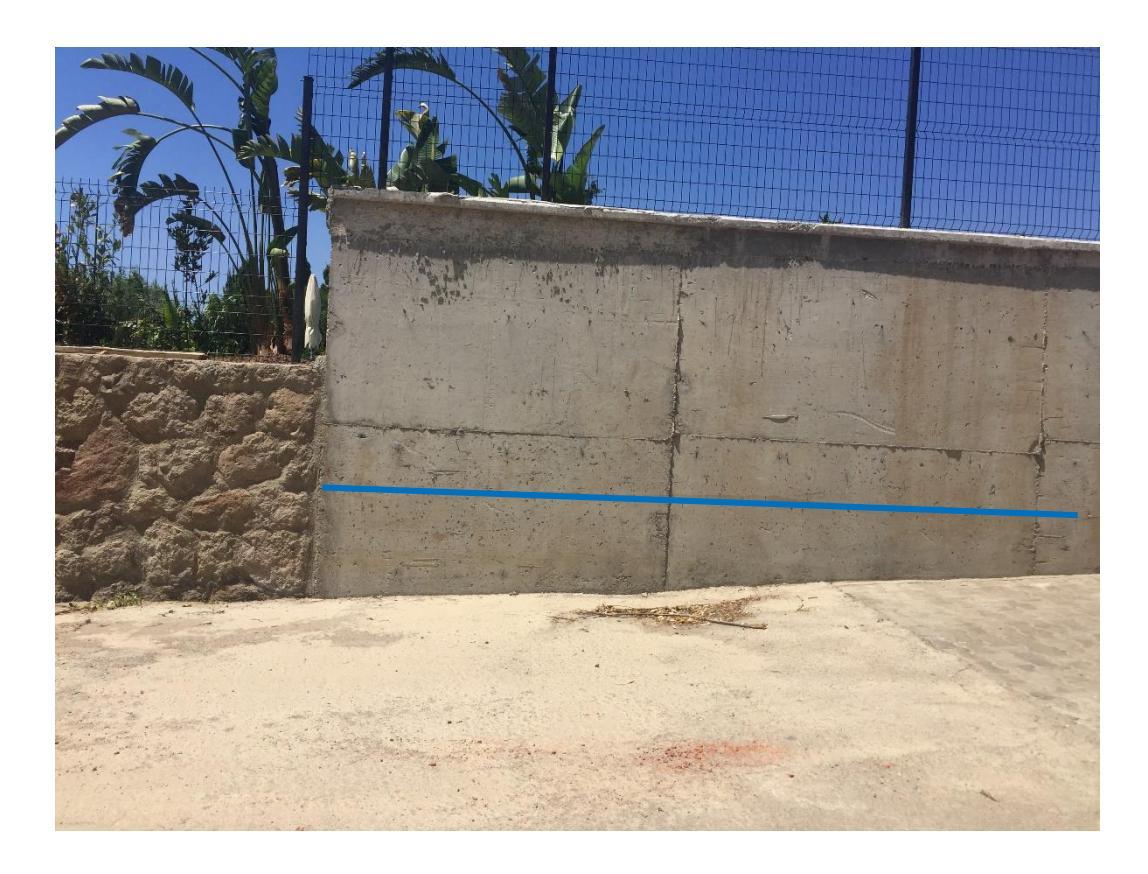
Figure 4.13: Wave trace on the sidewalls of the road, Karaincir Bay (27.300718E 36.973574N)

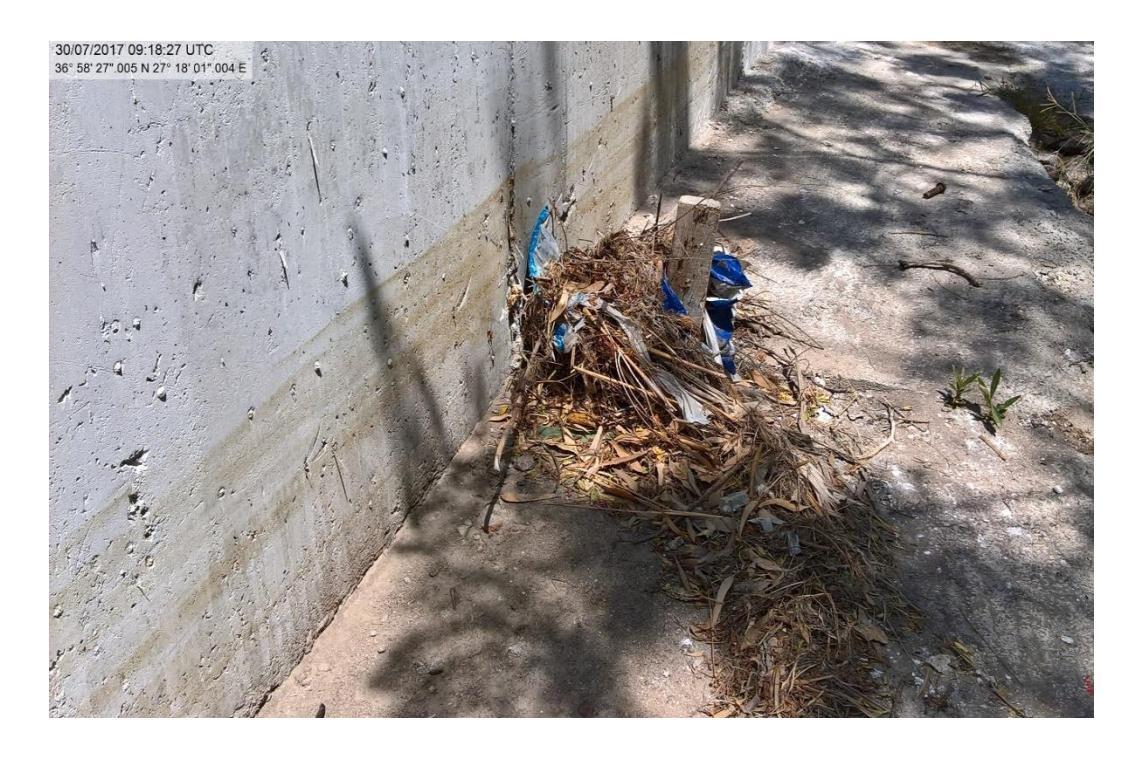
The field survey continued at Karaincir, Balmahmut's Place **(4)**. Inundation is reported approximately 60m near Atakan Beach, water drawdown is approximately 20m and the motion was like tidal wave according to the observers. The observers state that water level was first decreased and then rised up resulting in a total wave oscillation of +1.4m -1.2m. Also, in the second survey, the maximum run-up height is observed and measured in the stream bed (width: 2.5m) as 1.4m (0.8m flow depth + 0.6m elevation) at 100m away from the shore. Then the inundation was observed up to 150m along the stream bed. Furthermore, the traces on the walls of the stream bed shows that more than one wave (at least three waves) has reached (Figure 4.12) the Karaincir locality. The run-up height is also measured as 1.5m (0.5m flow depth + 1m elevation) on the road (width: 6m) just near the stream (Figure 4.13). The incoming wave washed away cars along the road. The visualization of the inundation can be described in Figure 4.14.

Figure 4.14: Debris material accumulated, Karaincir Bay (27.30041E, 36.97433N)

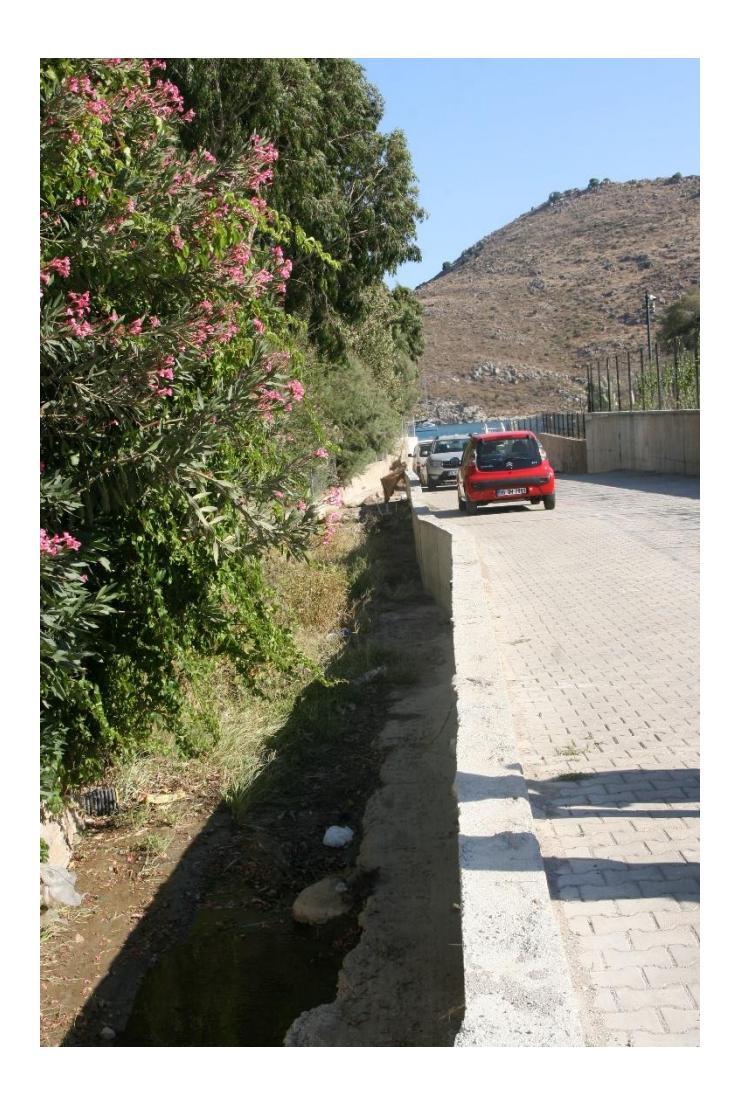
Figure 4.15: Maximum inundation distance in Karaincir Bay along the streambed

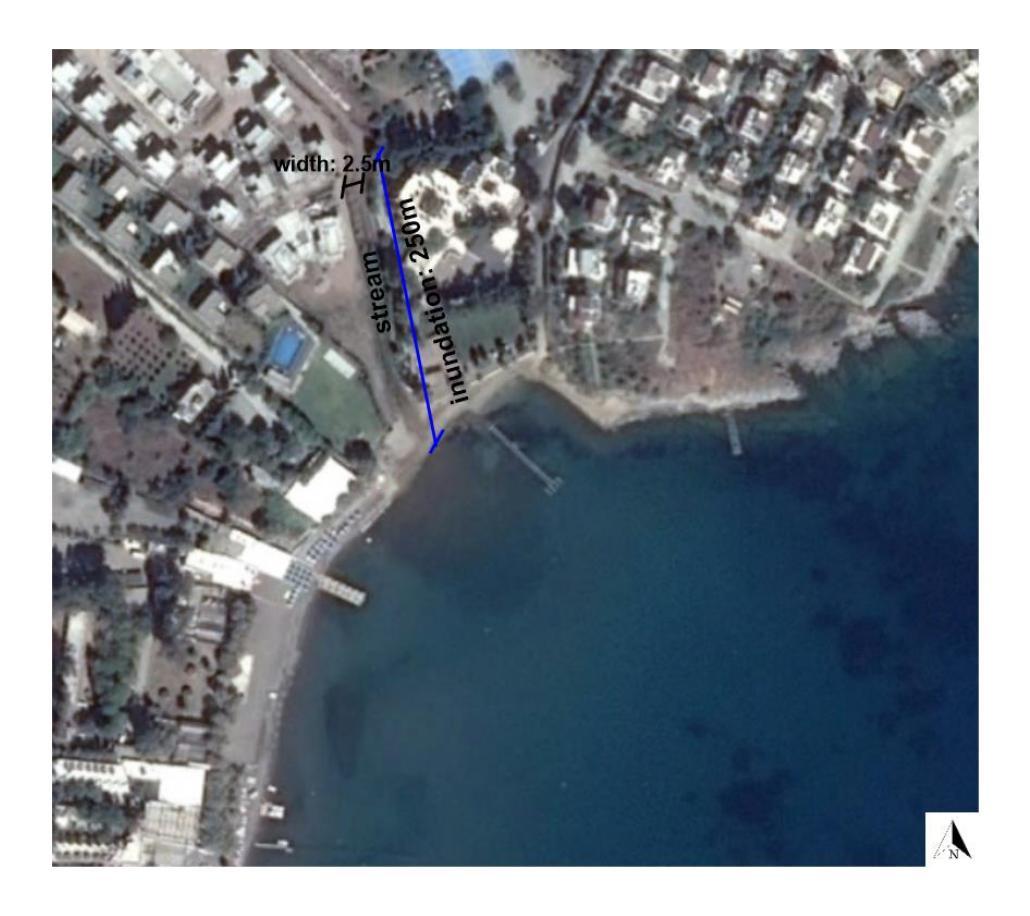
Figure 4.16: Schematic view of the inundation at Karaincir Bay (27.300496E 36.972961N)

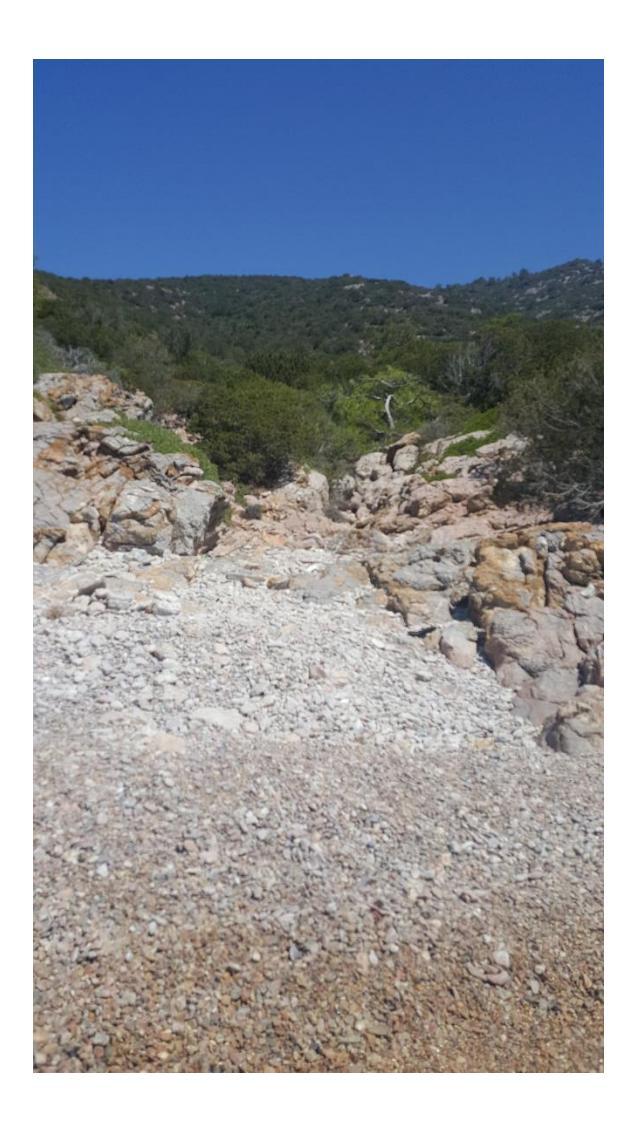
Karaada in English Black island, is located in between Bodrum town and Kos island with a size 7km along NW-SE direction and in average 1.2km along SW-NE direction. A special field survey has been performed to Karaada by boat on July 31, 2017 by Yalciner and Dogan). At south coast of island (facing to epicenter) there are two small gravel beaches. The view of small gravel beach at Kucuk Poyraz bay (27.461422E 36.966323N) is given in Figure 5.1 a and b from different perspectives.

Figure 5.1: Kucukpoyraz Gravel Beach at Karaada (Black Island) a) view from the shore b) view from the beach

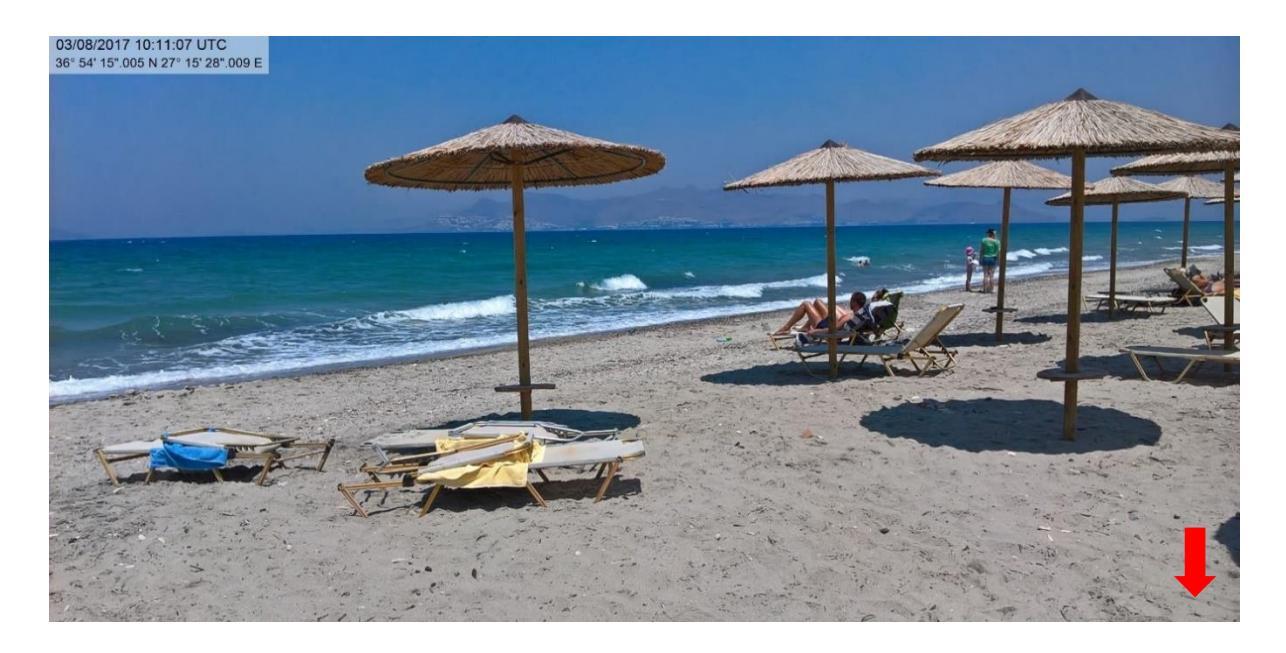
Figure 7.2: Image taken at 36.89991/27.24879, showing debris at elevation 0.1 m, point (2) in table 7.1; the sharp change is not clear if is due to the Tsunami (subsidence) or just to coastal

erosion.

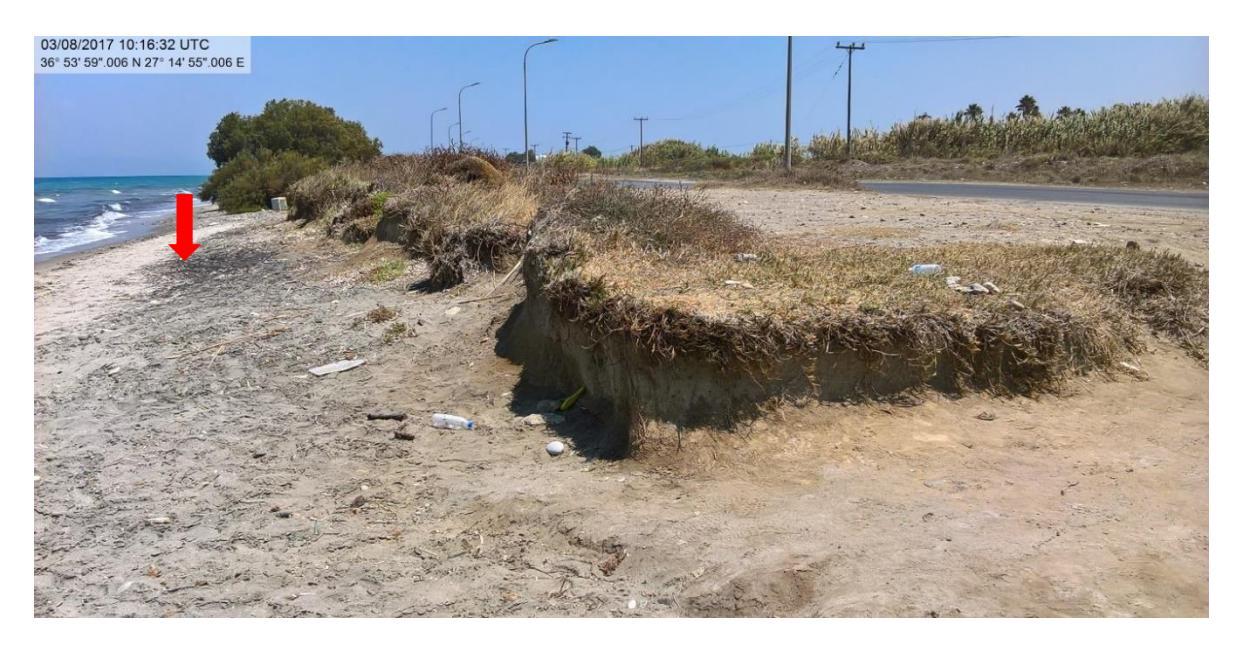
Figure 7.3: Image taken at 36.90433/27.25805. One witness, point (3), reported that the

beach was inundated by 16 m and corresponding to 0.5 m water height.

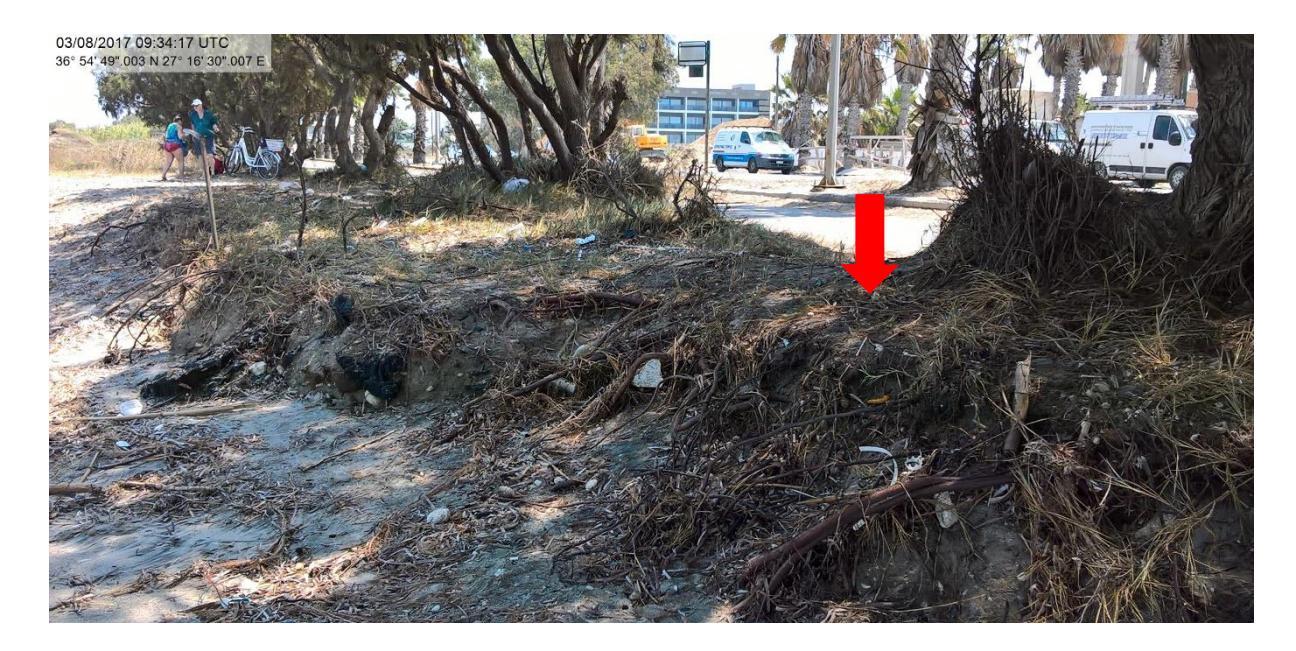
Figure 7.4: The image above was taken at 36.91370/27.27521 (5) and shows several sea deposits up to 1 m. The beach is very small, the distance from the sea is less than 5 m.

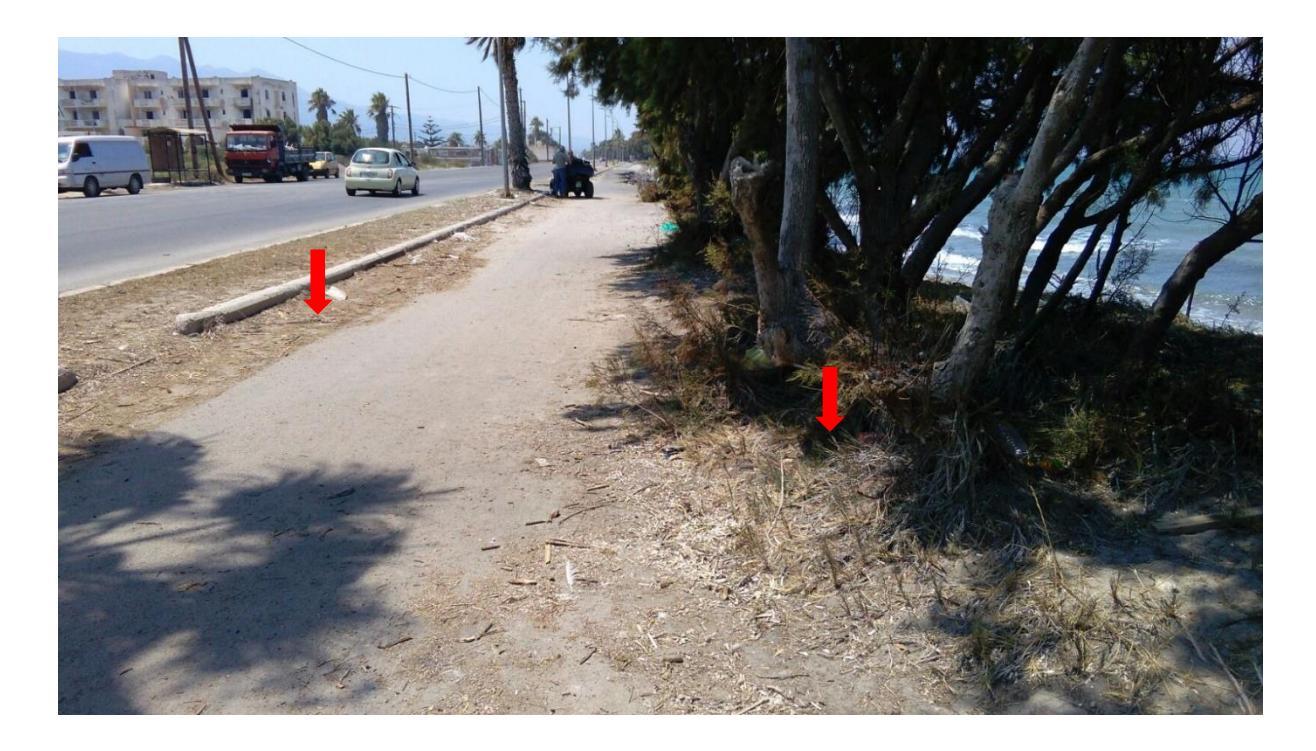
Figure 7.5: Image taken at 36.91358 / 27.27503, showing the presence of sea debris below the trees but also on the other side of the bicycle street.

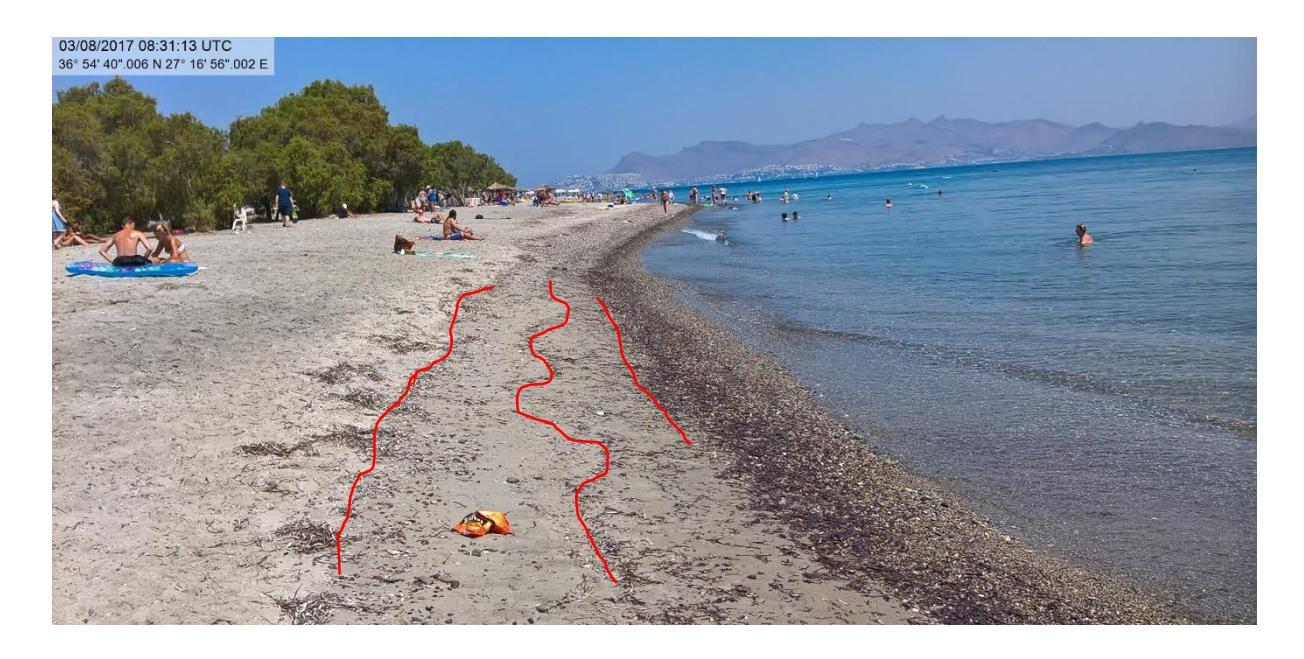
Figure 7.7: The image above, done at 36.91130 / 27.28229, point (9) shows multiple series of deposits which could indicate the presence of various waves. The maximum height here is

estimated 0.3 m.

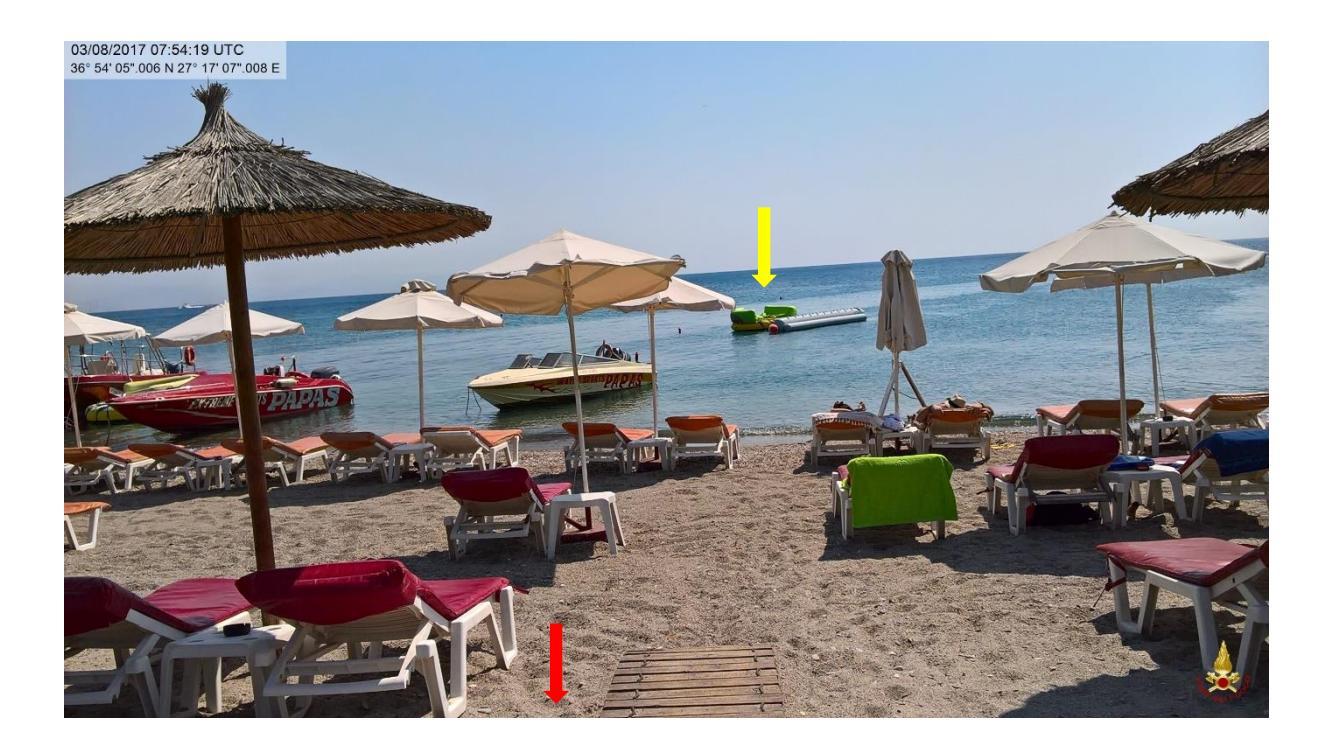
Figure 7.8: The image was done at 36.90156 / 27.28551, point (11). The height is between 0.5 and 1.2 m.

The largest height in this area before the port has been reported here by Dimitri Giagoglu, the owner of the beach, who also indicated that water receded several tents of meters (yellow buoy indicated by the yellow arrow) before advancing. He mentioned that, according to him, the magnitude was much larger, 7.5 or 8.0 as it was very very strong, cut umbrellas. He showed movement of a large

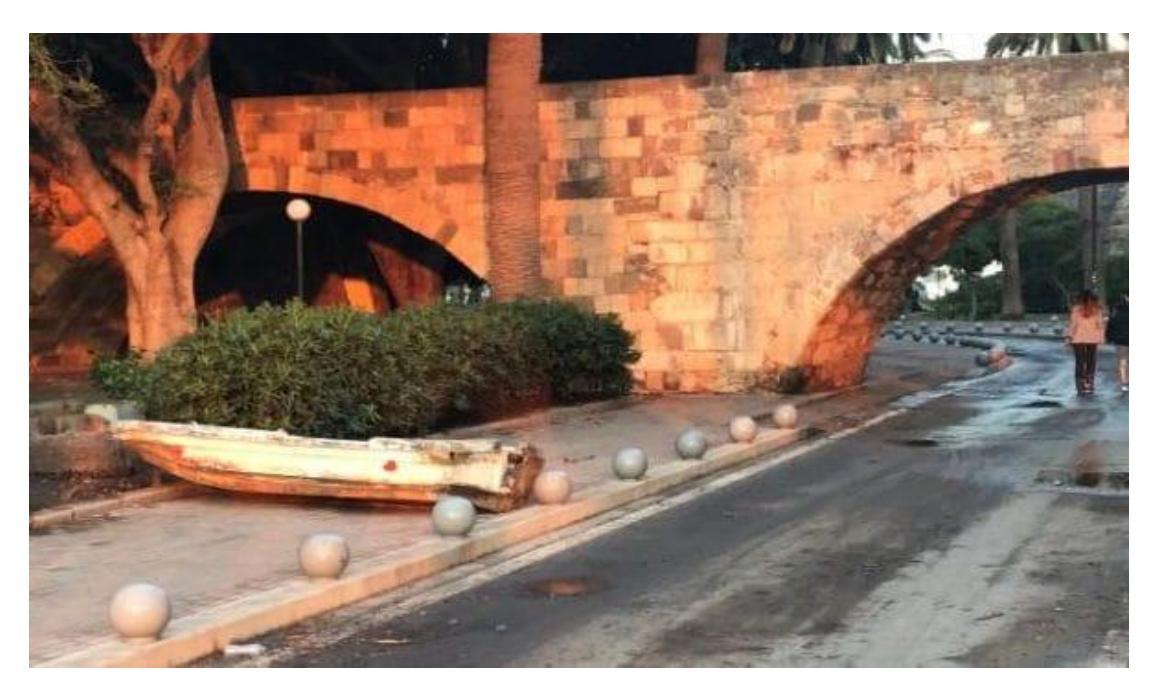
Figure 7.14: Boat resting on the pavement after its removal inland near the observation point 36.89478/ 27.28959, east side of Kos Port locally called "Bridge" (*photo credit Reuters*).

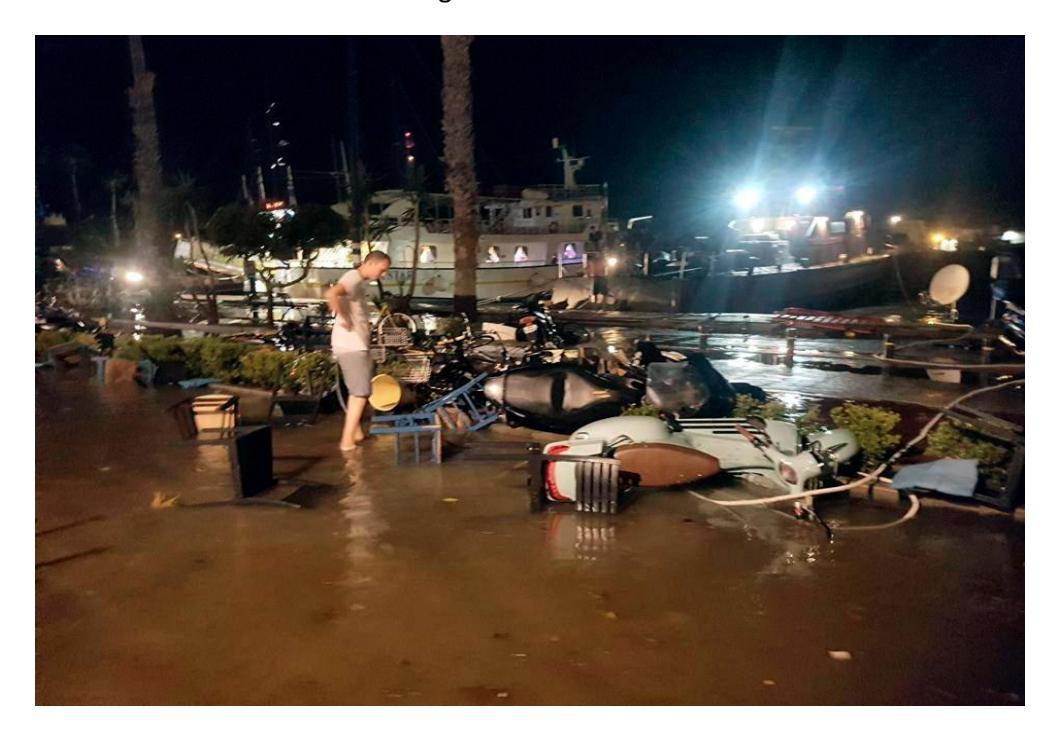
The Marina Officer Mr Kostas Liakovassilis arrived near the "Bridge" point ~ 1-1.5h after the earthquake. The area was wet apparently due to previous tsunami inundation. Bikes and motorbikes had fallen down and drifted. Cars crashed and drifted (see next pictures). At that time, the sea level was ~1.5-2.0 below its usual place. In about 1-2 m the sea level increased quickly by ~0.5m above the dock level, inundated by ~25-30 m and removed away motorbikes. After that the water retreat and the sea remained at its normal place. As the dock is at about 1m from the sea level the estimated height is **1.5 m**.

Figure 7.15: Bikes, motorbikes and other objects overthrown and drifted by the tsunami in Port of Kos, near the "Bridge" point (photo credit ANA-MPE).

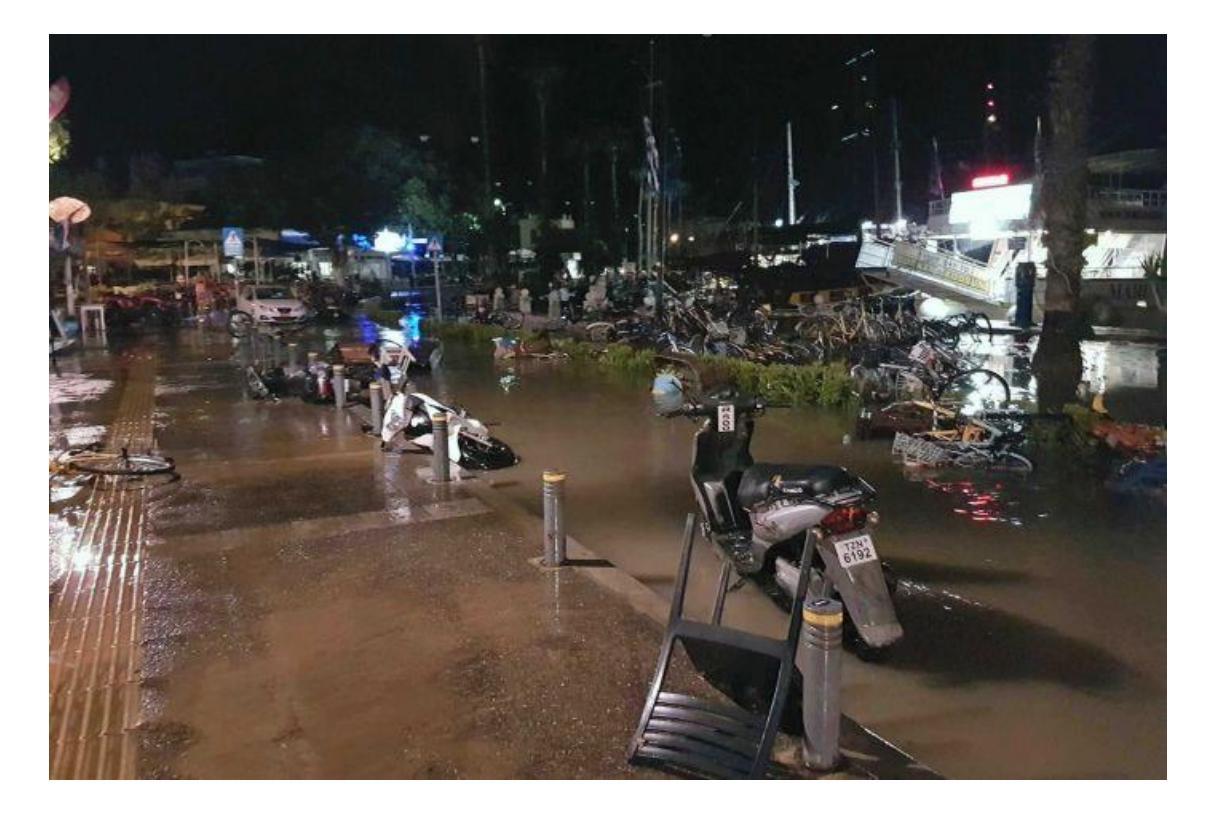
Figure 7.17: Bikes, motorbikes and other objects overthrown and drifted by the tsunami in Port of Kos, near the "Bridge" point (photo credit ANA-MPE).

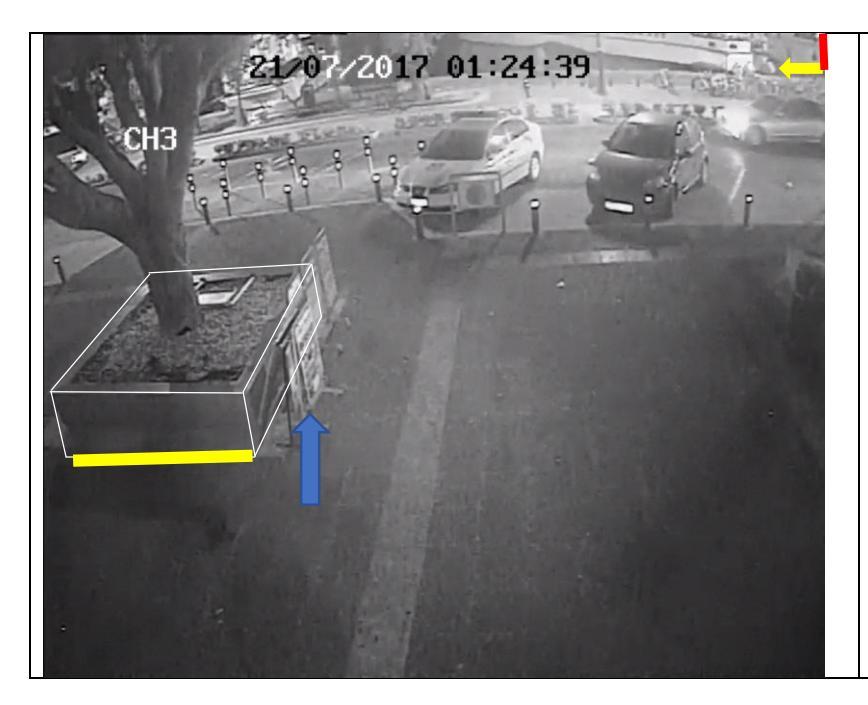
1 second before the earthquake strucks. Look at the position of the fenders of the boat in yellow and the light in the city, very bright. The yellow line indicates the bottom of the plant box that is very important to establish the water height.

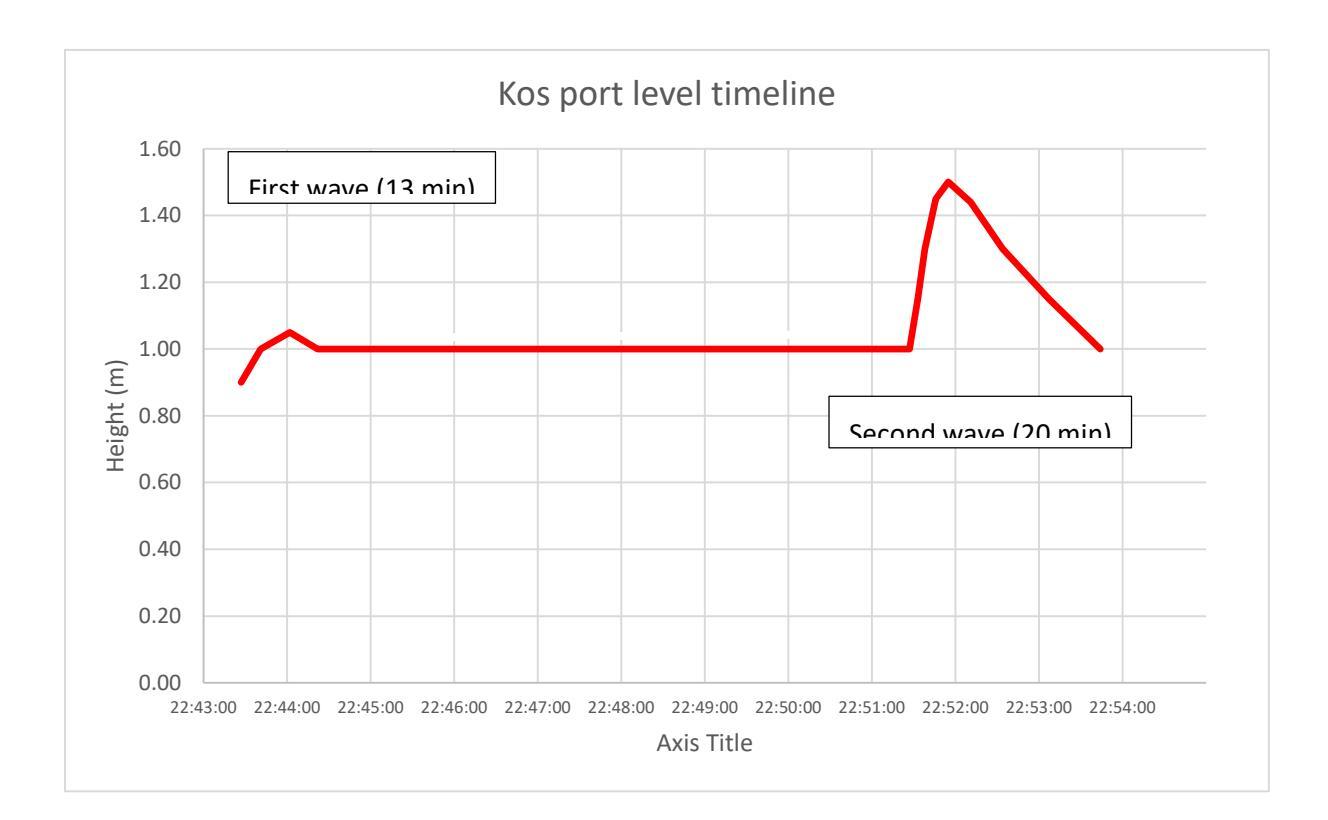
Figure 7.19: The analysis of the images and once corrected for the time delay, the plot represents the absolute height of the water, considering the location of the plant box (1 m from sea level) and the height of the plant box (46 cm). Then, the maximum 1.5 m, at the location of the plant box, occurs at 22:51 UTC but two distinct waves are present, 13 and 20 min after the earthquake.

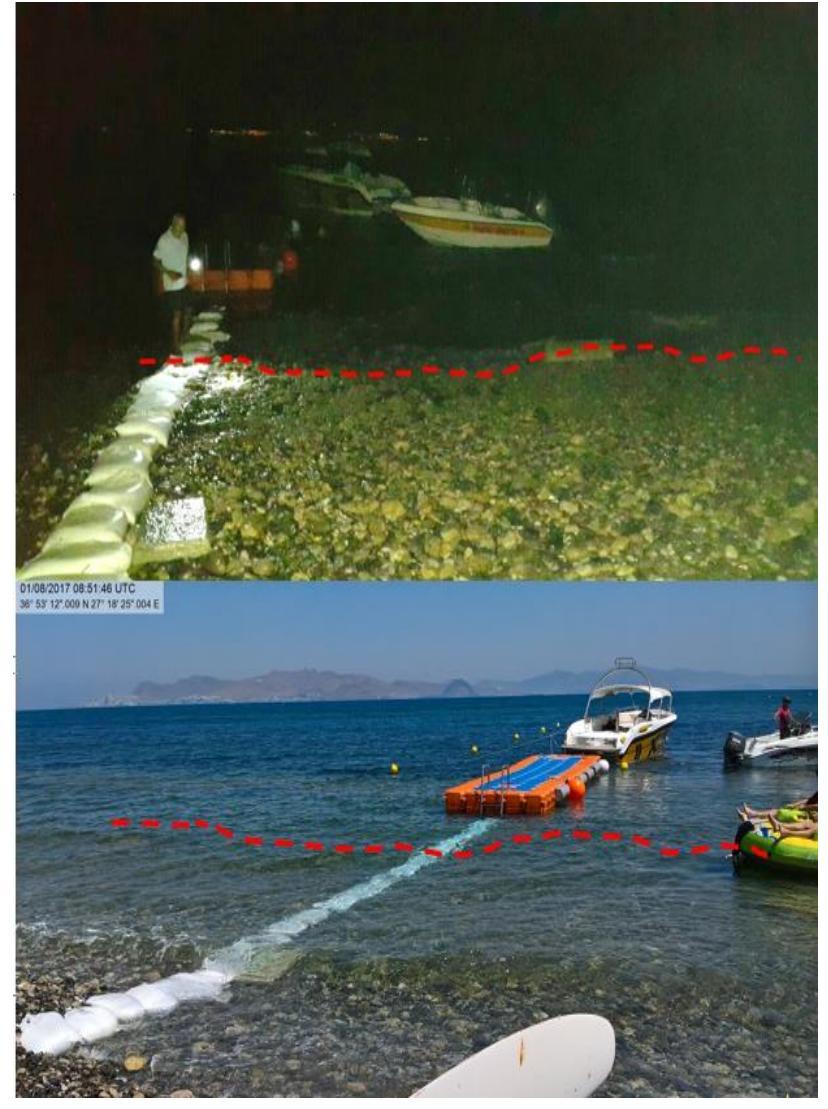
eyewitness, identifying himself as *Mike*, shows the water receding during one of the multiple waves arrivals (he mentioned that this was not the first one but he could not indicate the right time of the image). The shoreline is advanced to from its normal position (following figure). Counting the white sand bags, it seems that approximately **7-8 m** is visible.

Figure 7.20: The water receding during one of the multiple waves arrivals (at 27.30707E 36.88694N, position 14)

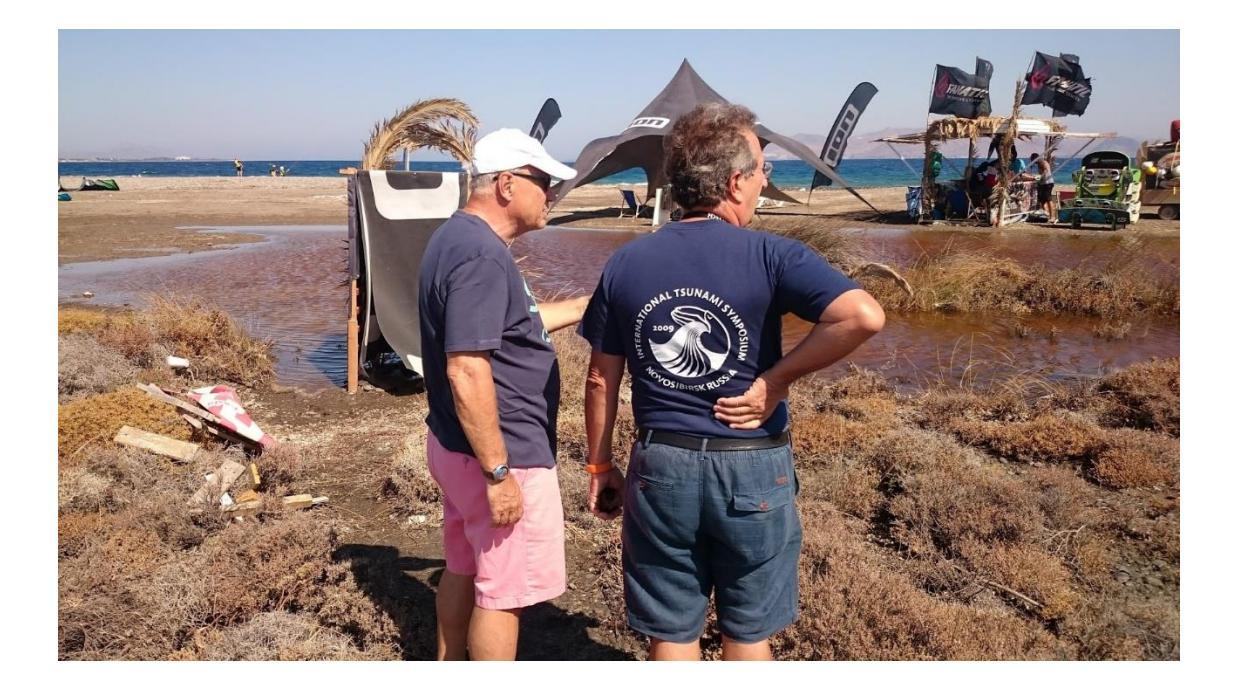
An alternative is the local subsidence that may have occurred in the Cape Louros due to the earth shaking with the large earthquake. Subsidence evidence comes from the observations at the lighthouse-antenna place, as reported above. In addition, the Mayor of Kos Mr George Kyritsis told us that two scuba divers reported to him that the sea floor around Cape Louros had deepen significantly after the earthquake. Local subsidence may have caused the very shallow water table to expose above the surface thus creating the local lake.

Subsidence evidence comes also from the marshy field situated next to the lake. In this field, we observed ground failures typical for soil liquefaction due to earthquake shaking. Namely, in the soft ground we observed fissures and local depressions, while an extensive area of the marshy field was covered by an extensive mantle of soft sand that came out from ground fissures and depressions. The sand mantle covers an area of ~30m in length and ~ 12-15m in width. A global dataset was used by de Magistris et al. (2014) to identify, on the basis of simple statistical analysis, a PGA threshold on the free ground surface below which liquefaction is unlikely to occur, regardless of the geological site conditions. The calculated value is on the order of 0.07– 0.1 g^7 .

Figure 7.29: G. Papadopoulos and A. Annunziato (with the official T-shirt of a past Symposium) discussing about the formation of the lake at Cape Louros

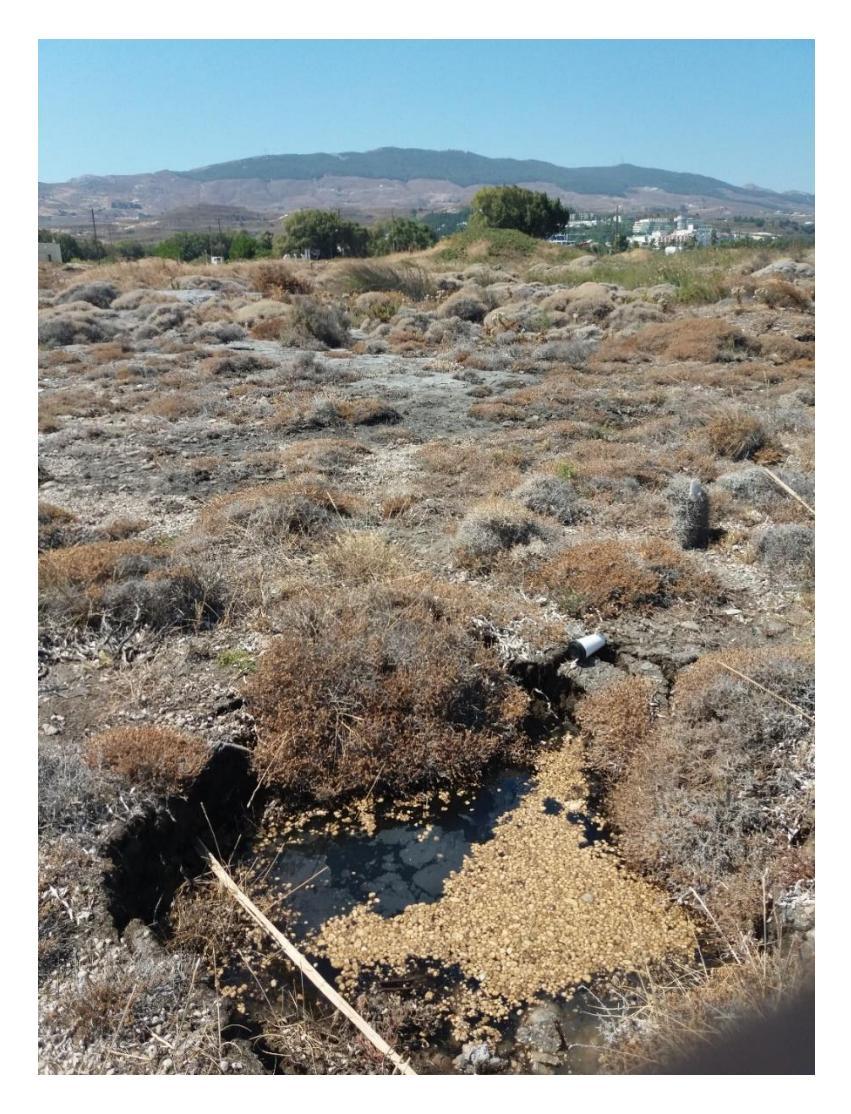
Local ground depression in the liquefied area. Sand mantle is shown at the background.

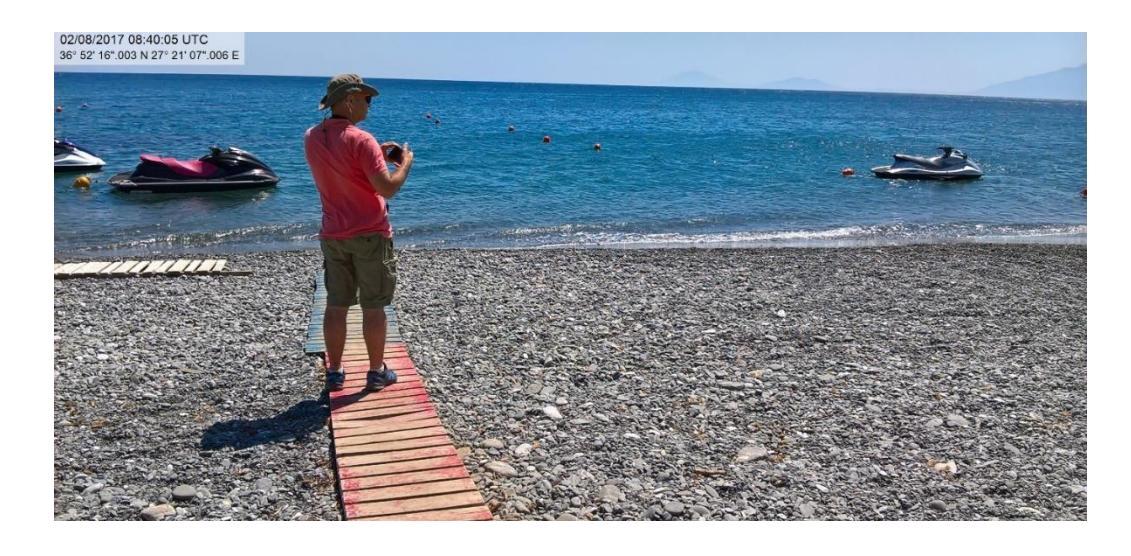
As the height at Louros Cape varied between **0.1 and 0.5 m** the estimated height, by the deposits, restarted to increase up to **0.7 m**.

Figure 7.30: At this location 36.87120/27.35213, point (19), the estimated height is about 0.7

m.

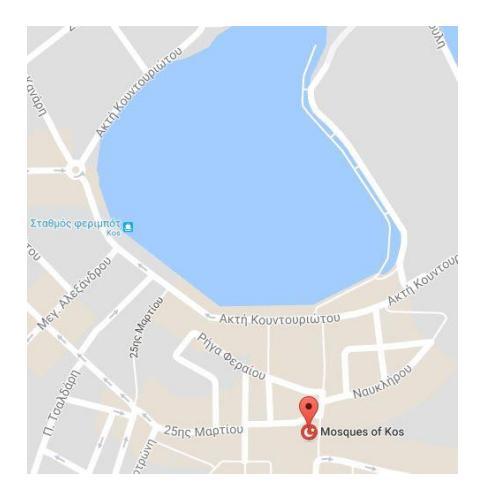
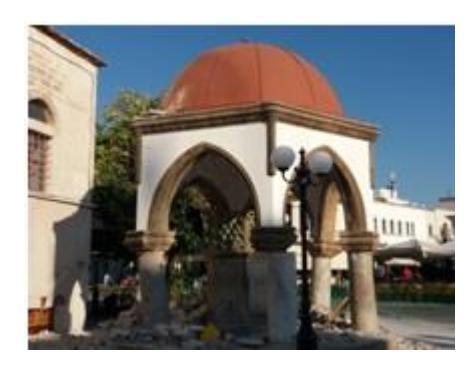
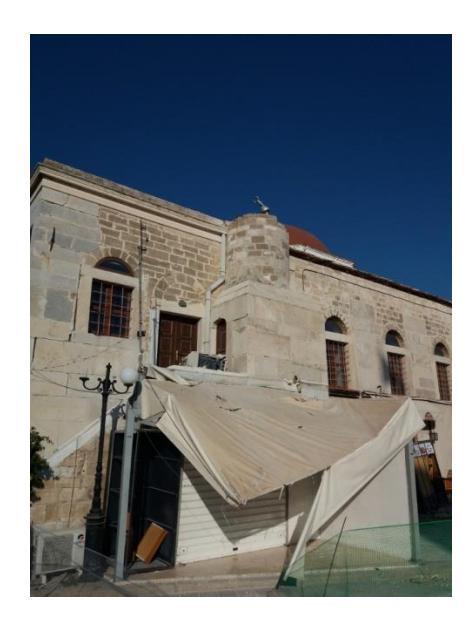
Figure 7.36: The minaret of the Mosque of Defterdar, built in Eleftherias Square at the end of 18th century (old part of the Kos city) collapsed due to the earthquake, only its base remained.
