THE 20th JULY 2017 (22:31 UTC) BODRUM/KOS EARTHQUAKE AND TSUNAMI; POST TSUNAMI FIELD SURVEY REPORT

August 17, 2017 (new version)

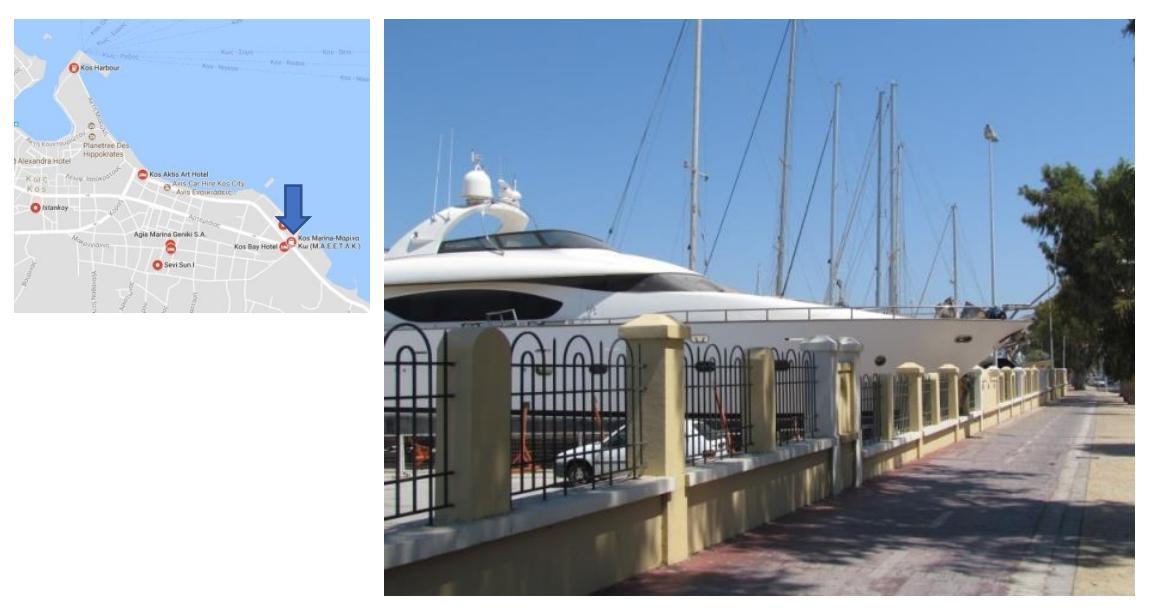
A sliding ship from the holder attachments at the marina was seen because of the strong shaking from the earthquake.

Figure 7.39: A) Location of the marina B) Sliding the ship from attachments to the walking road
